Material Test Report

Report No: MAT:12-02155-W4-S1
Issue No: 1

Re: Mohs Hardness Testing
2016 Construction Projects
Schofield, WI
AET Project No. 12-02155

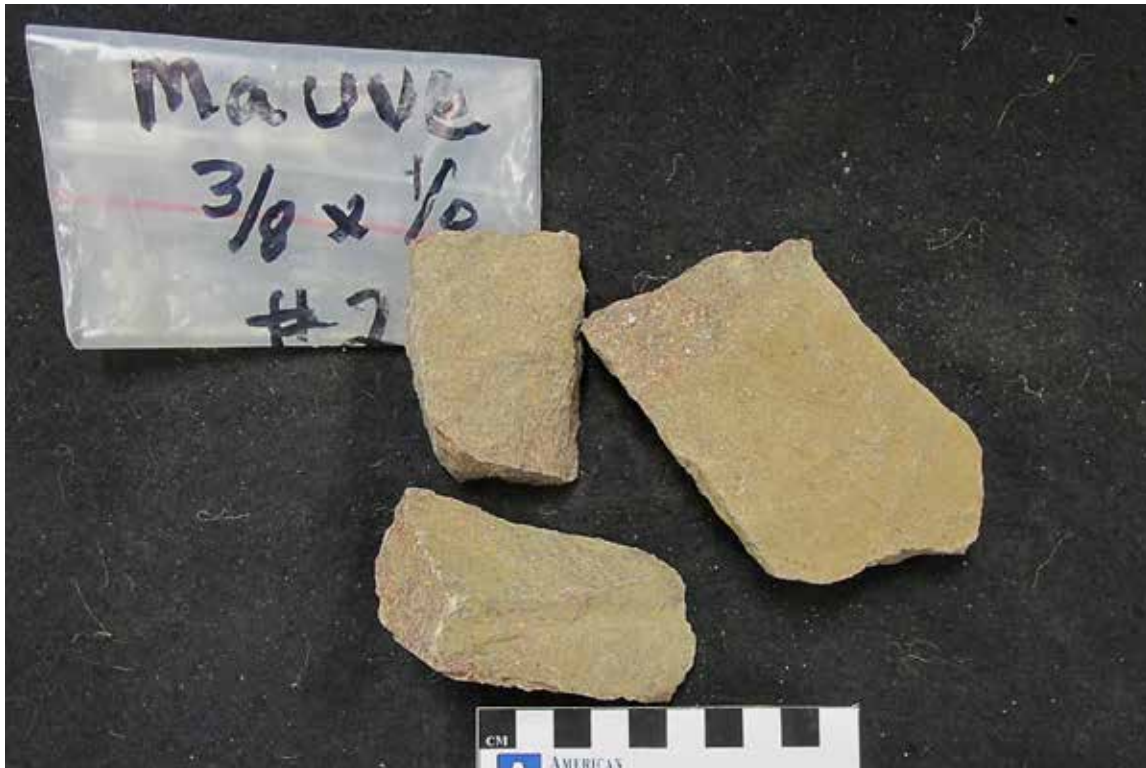
PHOTO: 1

SAMPLE ID: Sample #2-Mauve 3/8x1/8 **DESCRIPTION:** Overall view of the sample as received.

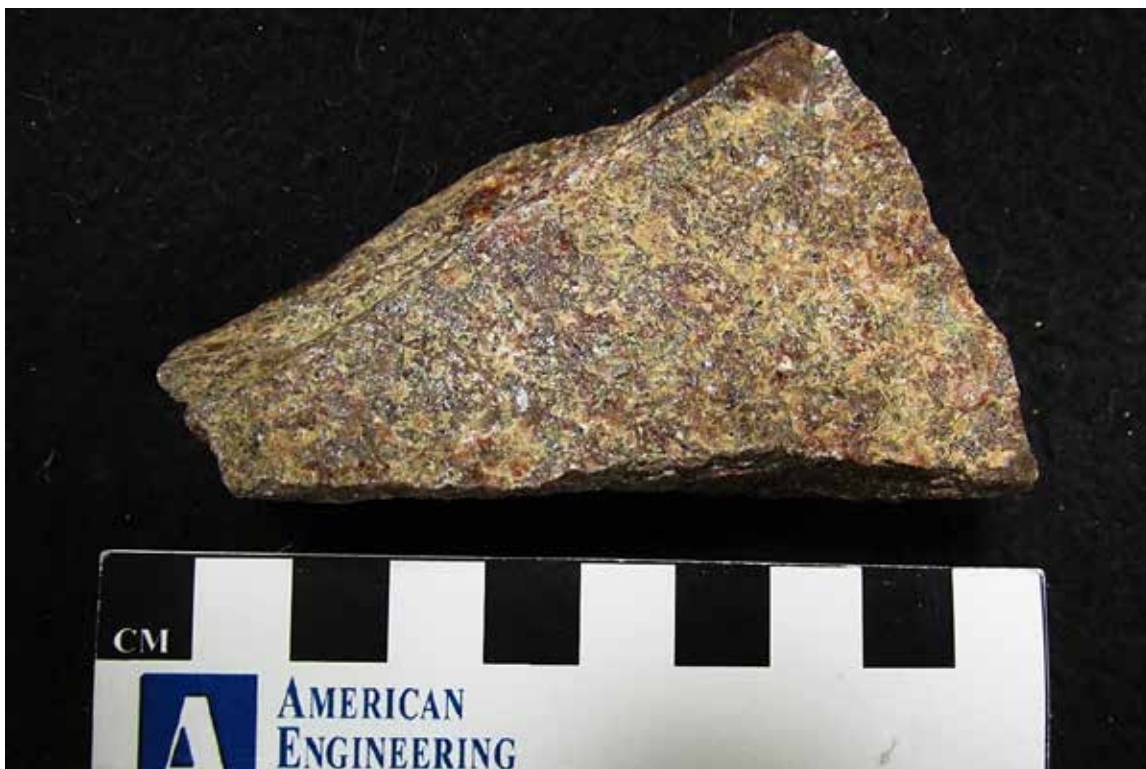
PHOTO: 2

SAMPLE ID: Sample #2-Mauve 3/8x1/8 **DESCRIPTION:** View of the stone selected for hardness testing.

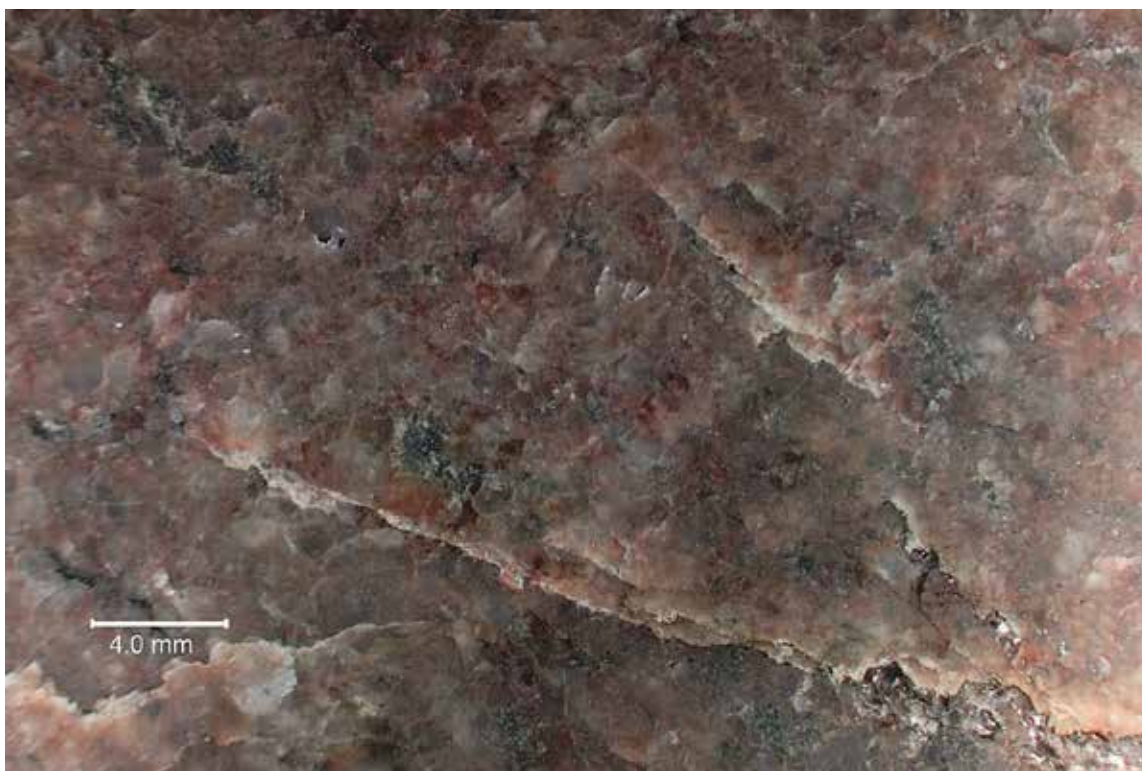
PHOTO: 3

SAMPLE ID: Sample #2-Mauve 3/8x1/8
MAG: 5x
DESCRIPTION: View of the lapped cross section of the stone.

Our work was performed on April 4, 2016 and subsequent dates. The hardness testing was completed through the use of standard geologic Mohs hardness points and optical microscopy on a lapped hand sample. The review was performed in general accordance with Standard Operating Procedure 24-LAB-004, "Petrographic Examination of Aggregates for Concrete, ASTM C295." Observations were made using an Olympus SZX-12 stereo-zoom binocular microscope with magnification up to 160x.

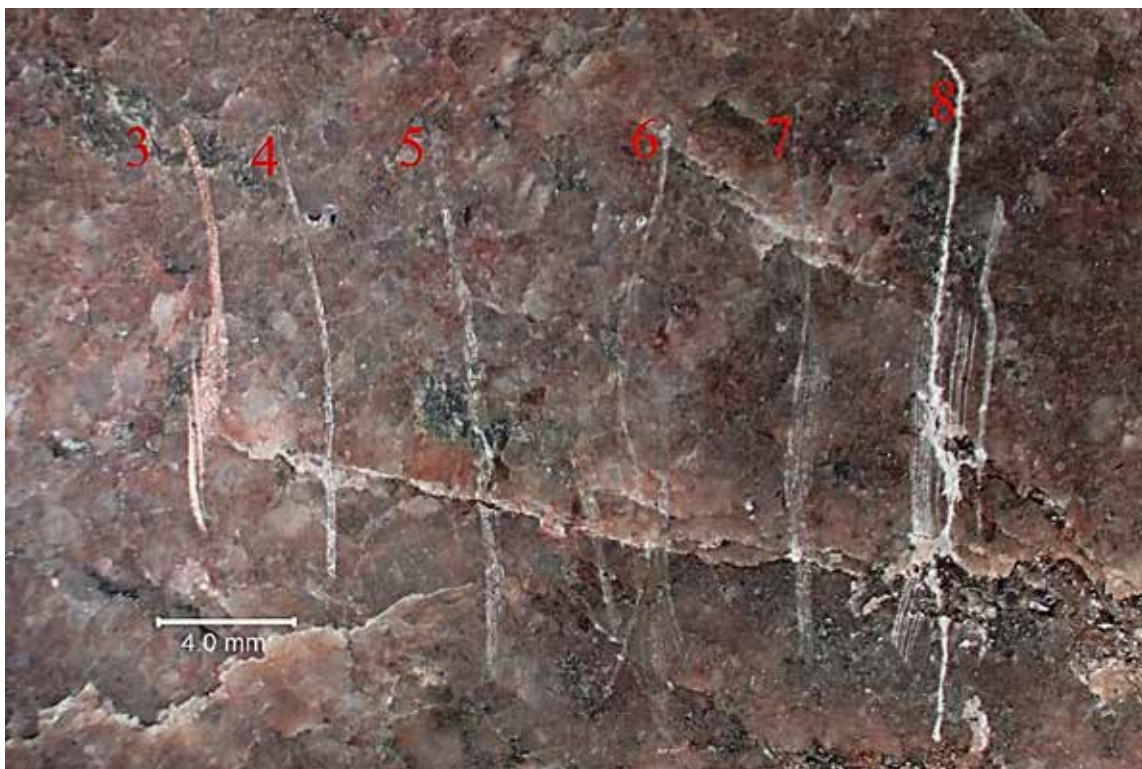
PHOTO: 4

SAMPLE ID: Sample #2-Mauve 3/8x1/8
MAG: 5x
DESCRIPTION: View of the lapped cross section of the stone after Mohs hardness testing. Note that hardness picks 3, 4, 5, and 6 did not scratch, hardness pick 7 scratched a few minerals, and hardness pick 8 scratched all minerals. The general Mohs hardness would be approximately 7.

1. The overall hardness of the "Sample #2-Mauve 3/8x1/8" stone is approximately 7 on the Mohs scale. The number is based upon testing values of the overall hardness of the rock using Mohs hardness picks.

2. The stone was a coarse grained, hard igneous rock. A hardness value determination of the stone based upon the mineral assemblage was not conducted. Mohs picks with hardness 3 thru 8 were used on the stone. The Mohs hardness picks determined an approximate overall hardness of 7. This hardness is a more consistent result than using the mineral assemblage because the Mohs hardness picks were drawn directly across a freshly lapped surface of the stone.
