Material Test Report

Report No: MAT:17-00352-S5
Issue No: 2

Client: KAFKA GRANITE, LLC
Project: 2016 CONSTRUCTION PROJECTS
Job No: 12-02155

Re: Mohs Hardness Testing
2016 Construction Projects
Schofield, WI
AET Project No. 12-02155

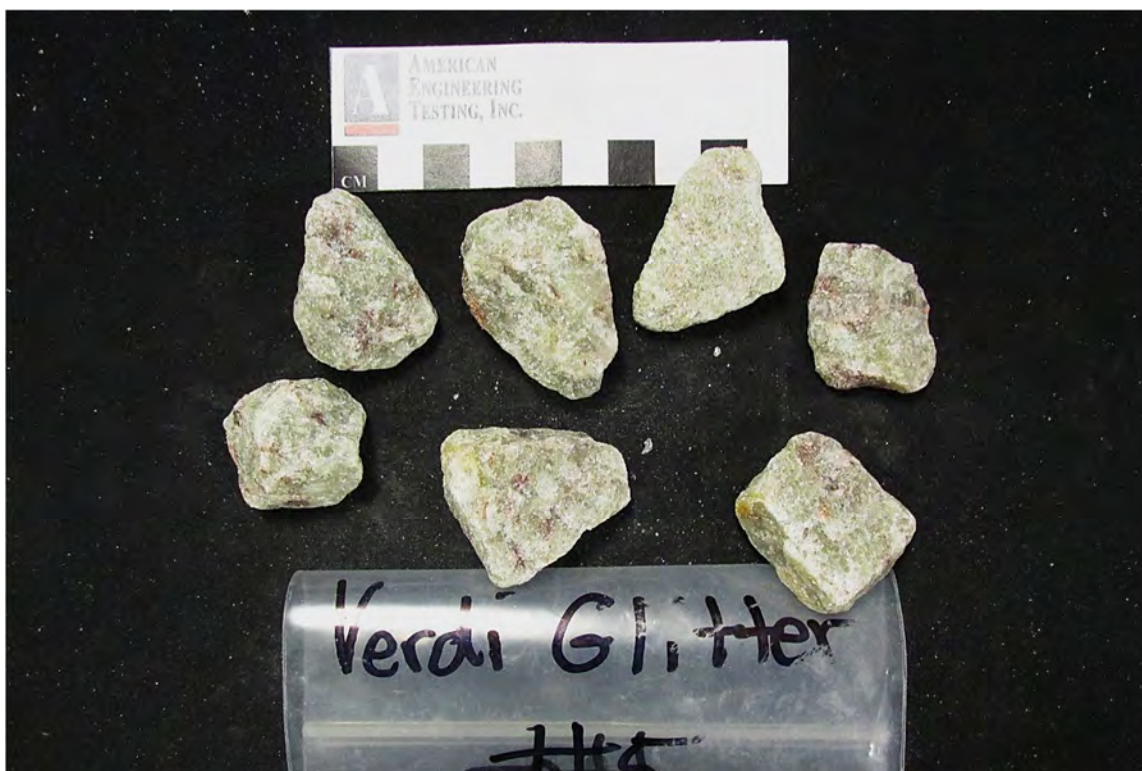
PHOTO: 1

SAMPLE ID: #5 Aspen Glitter DESCRIPTION: Overall view of the sample as received.

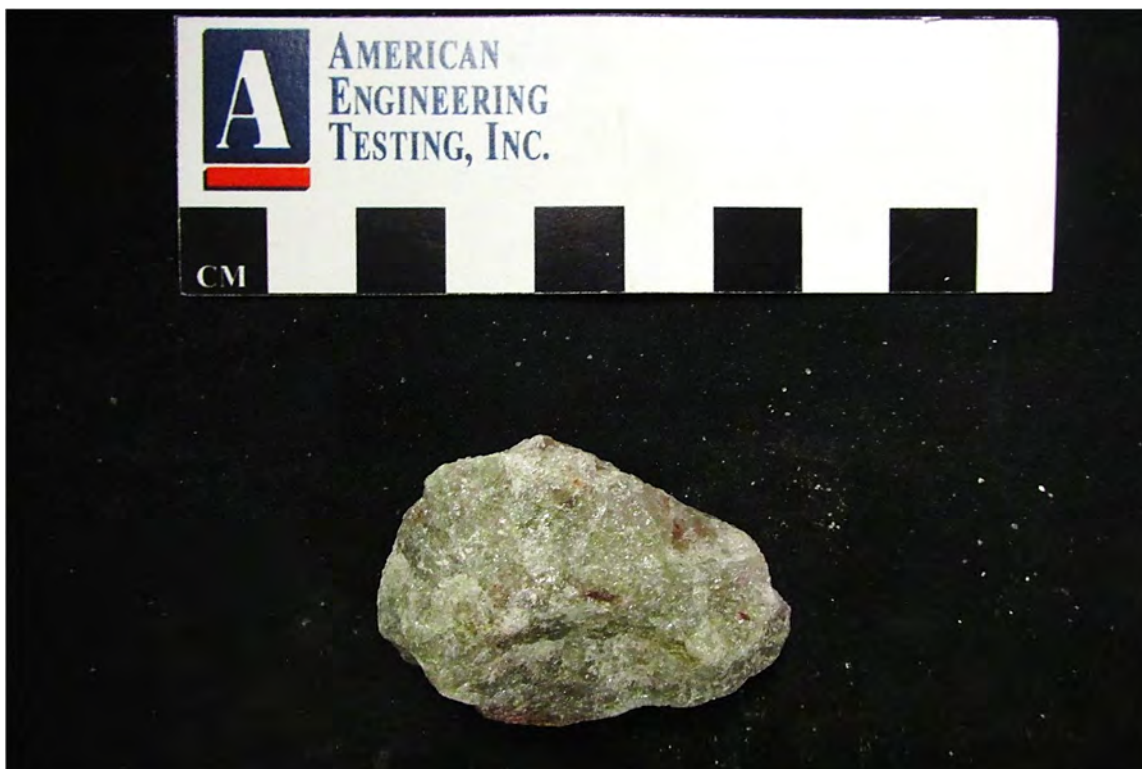
PHOTO: 2

SAMPLE ID: #5 Aspen Glitter DESCRIPTION: View of the stone selected for hardness testing.

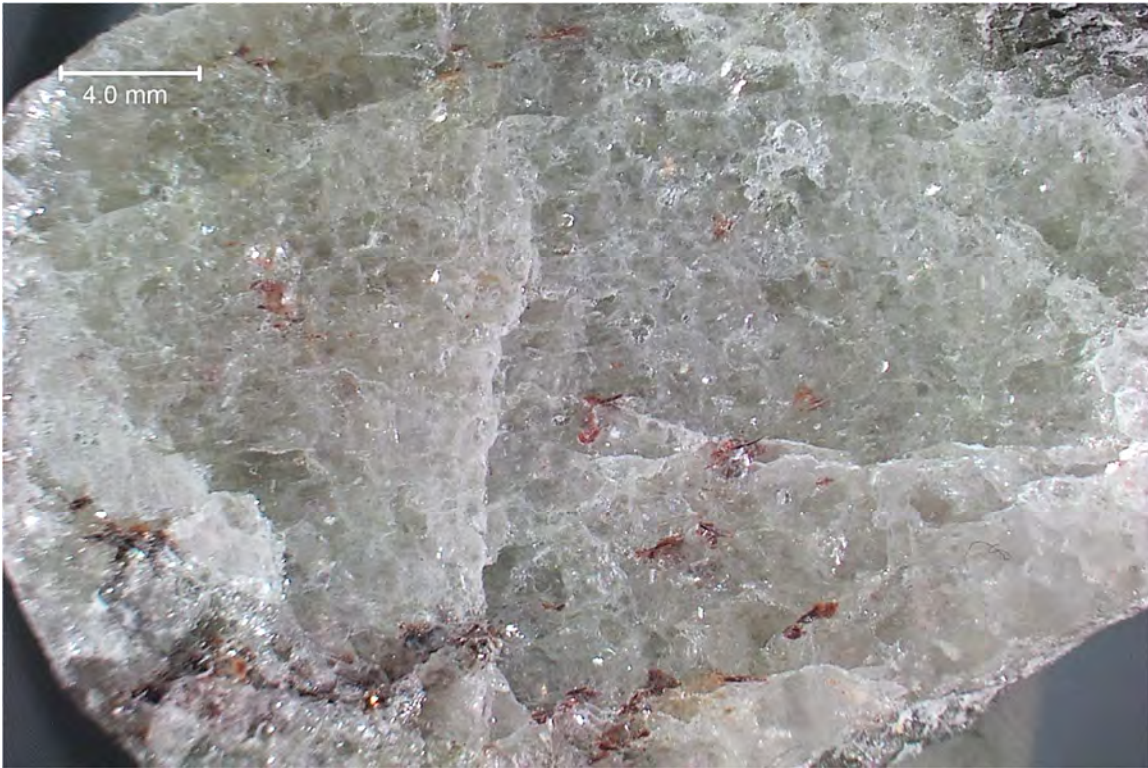
PHOTO: 3

#5 Aspen Glitter
5x

DESCRIPTION: View of the lapped cross section of the stone.

Our work was performed on January 16, 2017 and subsequent dates. The hardness testing was completed through the use of standard geologic Mohs hardness points and optical microscopy on a lapped hand sample. The review was performed in general accordance with Standard Operating Procedure 24-LAB-004, "Petrographic Examination of Aggregates for Concrete, ASTM C295." Observations were made using an Olympus SZX-12 stereo-zoom binocular microscope with magnification up to 160x.
