Material Test Report

Report No: MAT:16-07878-S11
Issue No: 1

Client: KAFKA GRANITE, LLC
CC: Jeremy Bores
 John Meyer
Project: 2016 CONSTRUCTION PROJECTS
Job No: 12-02155

Re: Mohs Hardness Testing
2016 Construction Projects
Schofield, WI
AET Project No. 12-02155

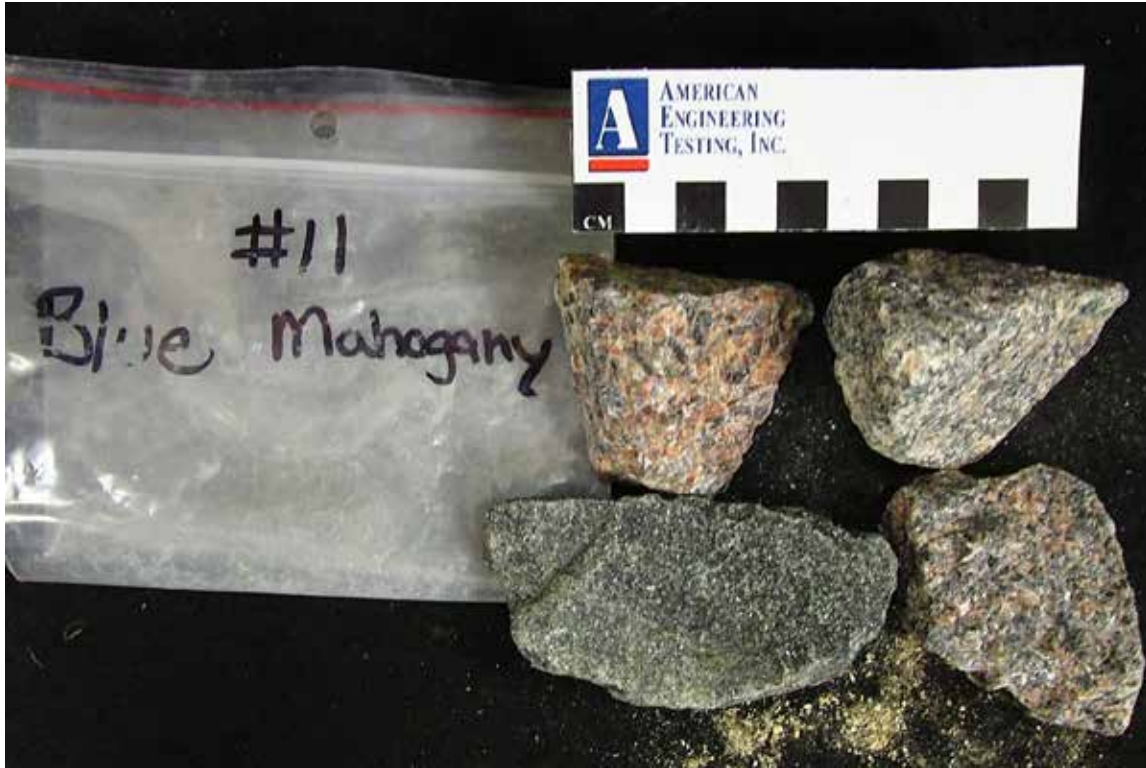
PHOTO: 1

SAMPLE ID: #11 Blue Mahogany DESCRIPTION: Overall view of the sample as received.

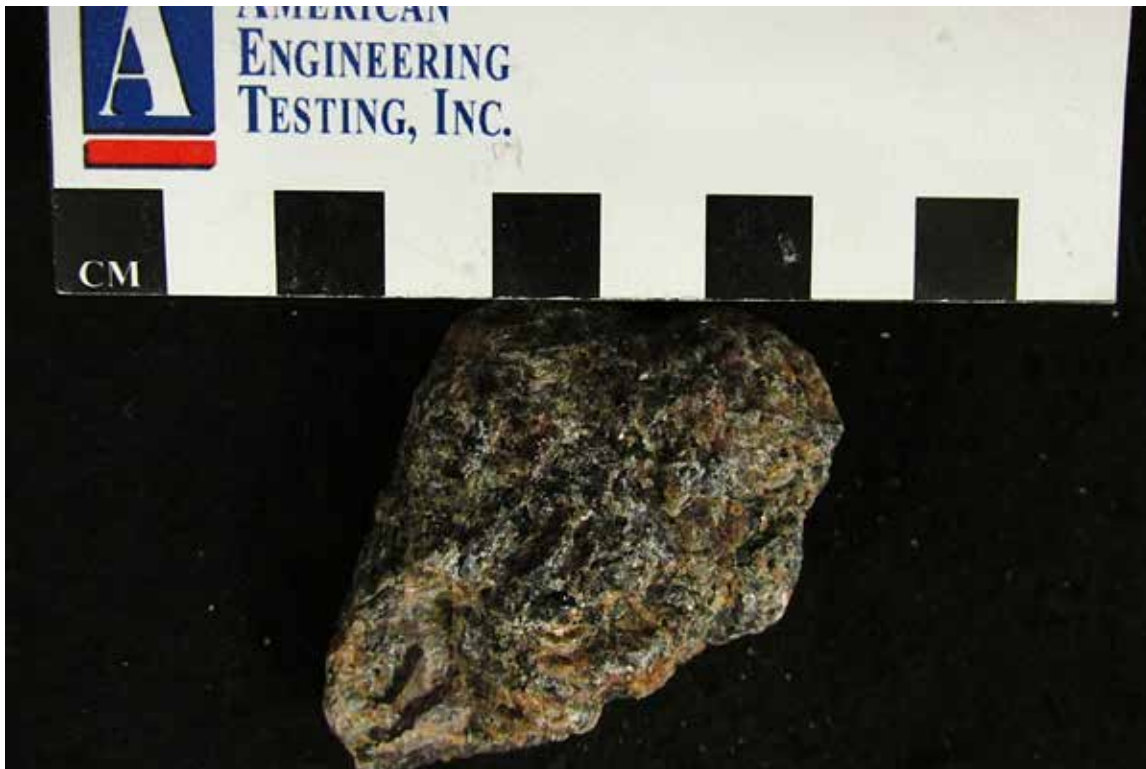
PHOTO: 2

SAMPLE ID: #11 Blue Mahogany DESCRIPTION: View of the stone selected for hardness testing.

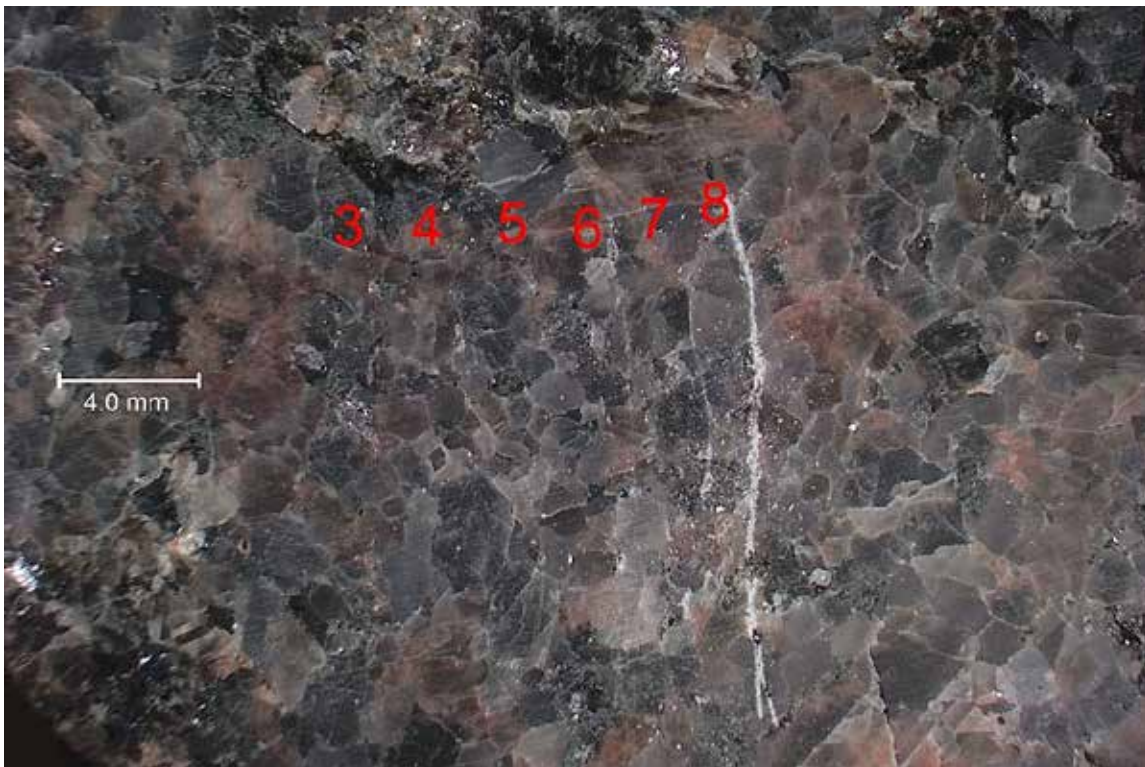
PHOTO: 4

SAMPLE ID: #11 Blue Mahogany
MAG: 5x
DESCRIPTION: View of the lapped cross section of the stone after Mohs hardness testing. Note that hardness picks 3 thru 6 did not scratch, hardness pick 7 scratched a few minerals, and hardness pick 8 scratched all minerals. The general Mohs hardness would be approximately 7 to 7.5.

1. The overall hardness of the "#11 Blue Mahogany" stone is approximately 7 to 7.5 on the Mohs scale. The number is based upon testing values of the overall hardness of the rock using Mohs hardness picks.

2. The stone appeared to generally consist of a medium grained, igneous rock. A hardness value determination of the stone based upon the mineral assemblage was not conducted. Mohs picks with hardness 3 thru 8 were used on the stone. The Mohs hardness picks determined an approximate overall hardness of 7 to 7.5. This hardness is a more consistent result than using the mineral assemblage because the Mohs hardness picks were drawn directly across a freshly lapped surface of the stone.
