# Material Test Report

**Report No: MAT:16-07878-S9**  
**Issue No: 1**

Re: Mohs Hardness Testing  
2016 Construction Projects  
Schofield, WI  
AET Project No. 12-02155

This report presents the results of our Mohs hardness testing of one sample of stone submitted by you on July 20, 2016. The stone is to be referred to as "#9 Botticino Marble". Four stones were submitted to our laboratory and one was chosen for testing. The scope of our work in this report was confined to performing Mohs hardness testing on one stone sample.

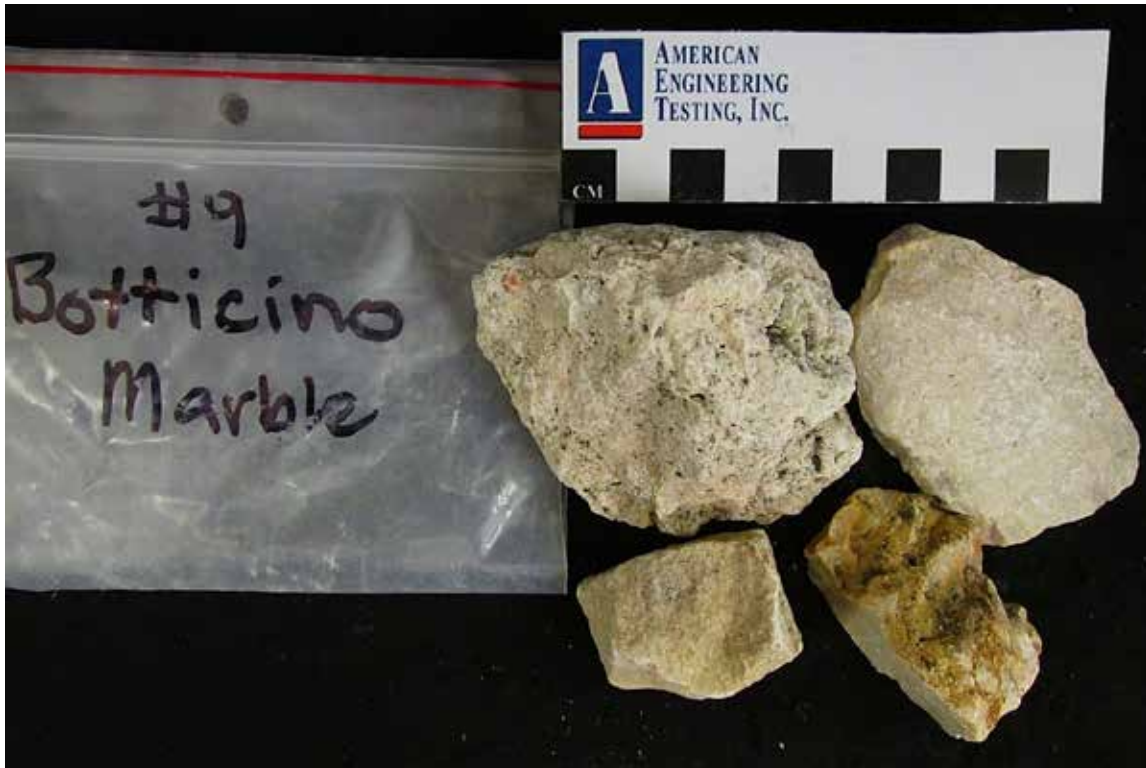
PHOTO: 1

SAMPLE ID: #9 Botticino Marble DESCRIPTION: Overall view of the sample as received.

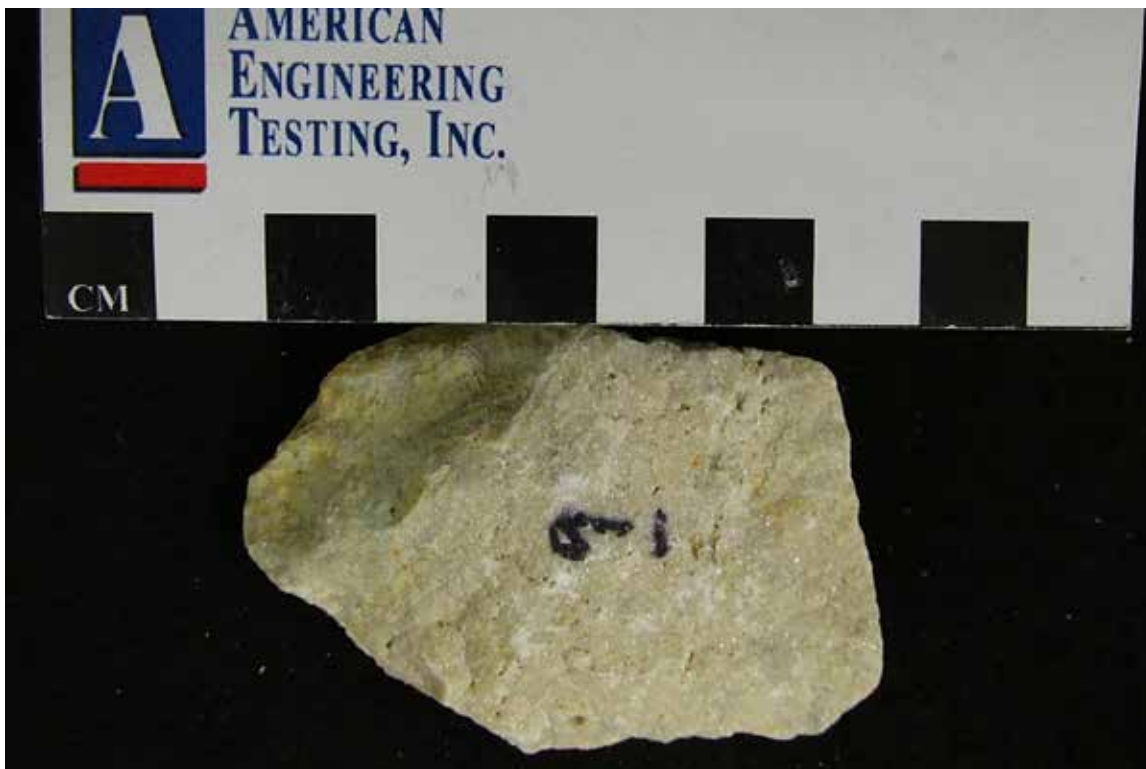
PHOTO: 2

SAMPLE ID: #9 Botticino Marble DESCRIPTION: View of the stone selected for hardness testing.

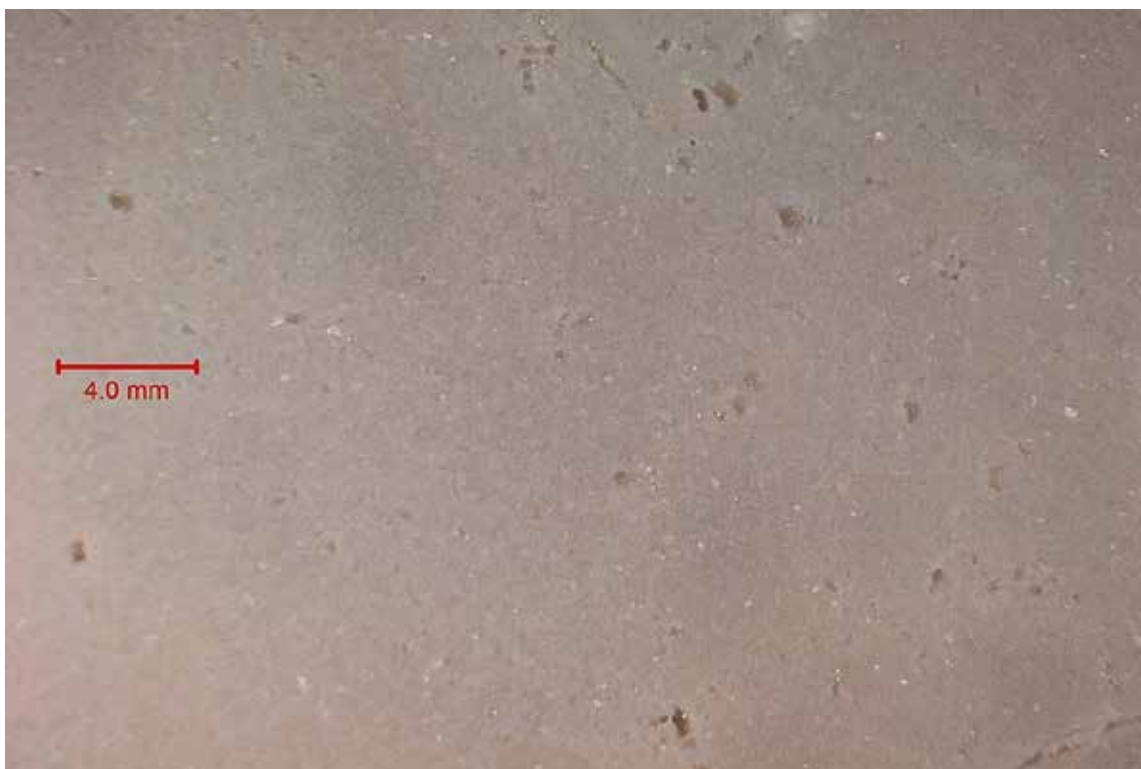
**PHOTO: 3**

**SAMPLE ID:** #9 Botticino Marble  
**MAG:** 5x

**DESCRIPTION:** View of the lapped cross section of the stone.

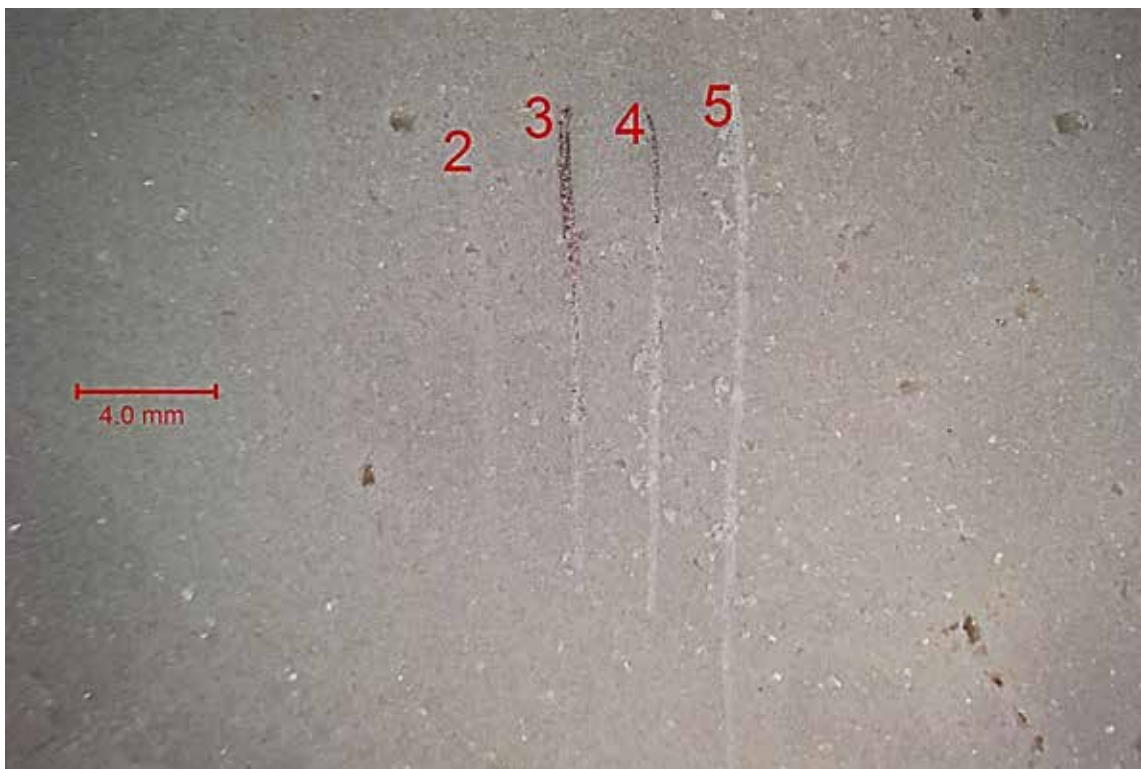
**PHOTO: 4**

**SAMPLE ID:** #9 Botticino Marble  
**MAG:** 5x

**DESCRIPTION:** View of the lapped cross section of the stone after Mohs hardness testing. Note that hardness pick 2 did not scratch, hardness picks 3 and 4 scratched a few minerals, and hardness pick 5 scratched all minerals. The general Mohs hardness would be approximately 3 to 3.5.

1. The overall hardness of the "#9 Botticino Marble" stone is approximately 3 to 3.5 on the Mohs scale. The number is based upon testing values of the overall hardness of the rock using Mohs hardness picks.

2. The stone appeared to generally consist of a fine grained, sedimentary rock. A hardness value determination of the stone based upon the mineral assemblage was not conducted. Mohs picks with hardness 2 thru 5 were used on the stone. The Mohs hardness picks determined an approximate overall hardness of 3 to 3.5. This hardness is a more consistent result than using the mineral assemblage because the Mohs hardness picks were drawn directly across a freshly lapped surface of the stone.
