Material Test Report

Report No: MAT:16-07878-S16
Issue No: 1

Client: KAFKA GRANITE, LLC
Project: 2016 CONSTRUCTION PROJECTS
Job No: 12-02155

Re: Mohs Hardness Testing
2016 Construction Projects
Schofield, WI
AET Project No. 12-02155

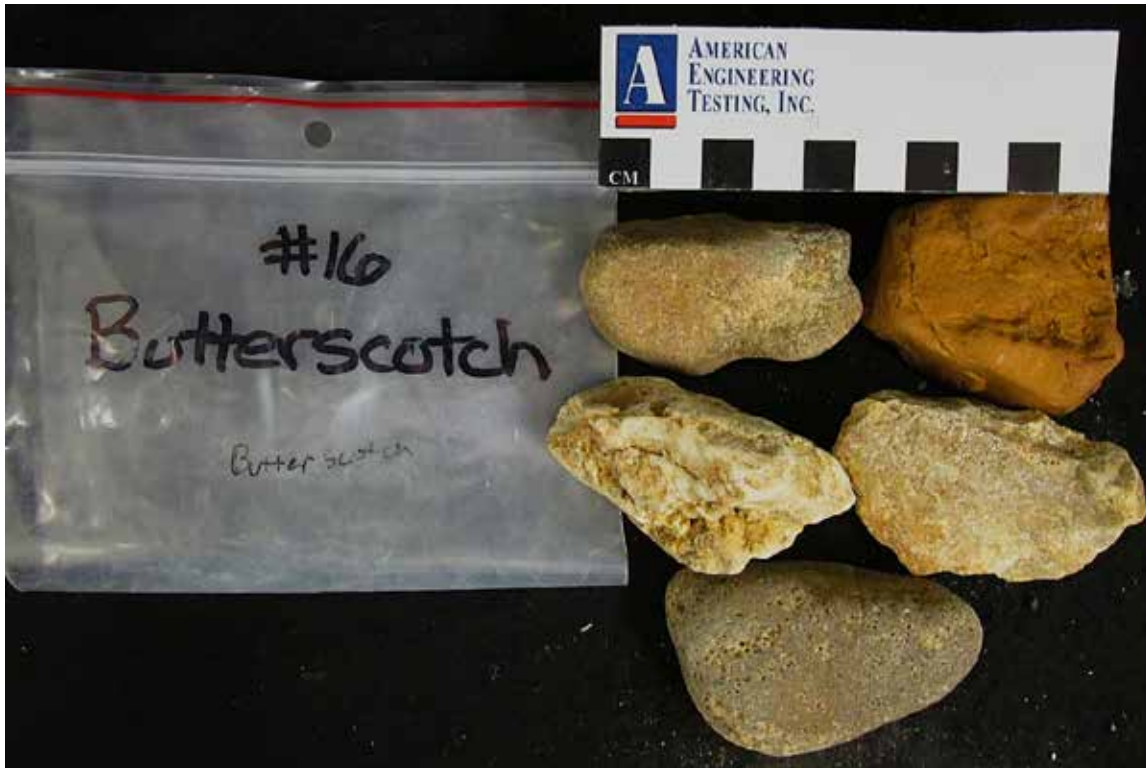
PHOTO: 1

SAMPLE ID: #16 Butterscotch DESCRIPTION: Overall view of the sample as received.

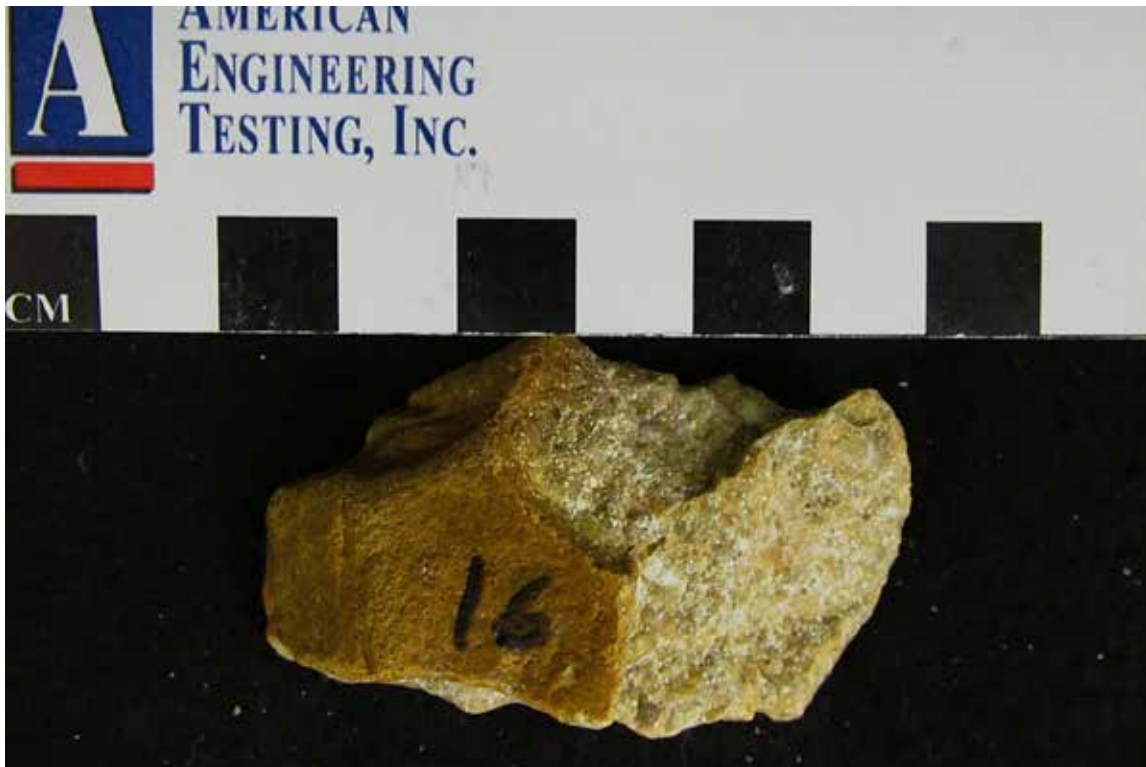
PHOTO: 2

SAMPLE ID: #16 Butterscotch DESCRIPTION: View of the stone selected for hardness testing.

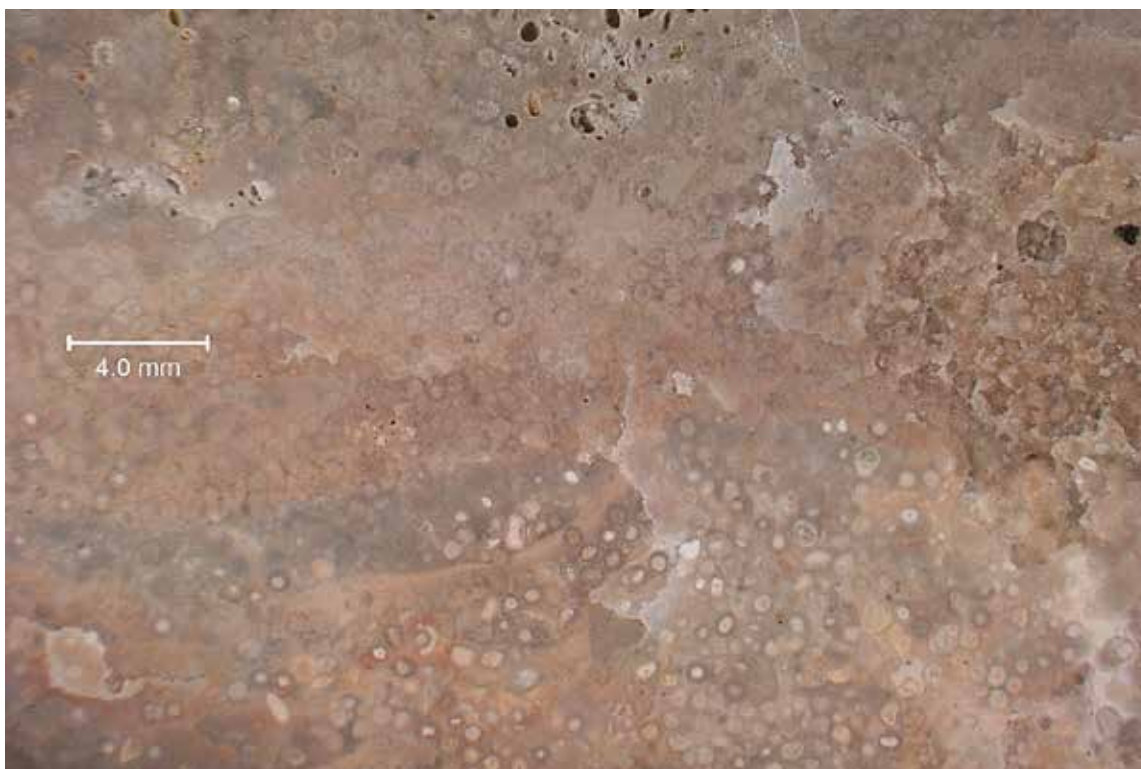
PHOTO: 3

DESCRIPTION: View of the lapped cross section of the stone.

Our work was performed on July 26, 2016 and subsequent dates. The hardness testing was completed through the use of standard geologic Mohs hardness points and optical microscopy on a lapped hand sample. The review was performed in general accordance with Standard Operating Procedure 24-LAB-004, "Petrographic Examination of Aggregates for Concrete, ASTM C295." Observations were made using an Olympus SZX-12 stereo-zoom binocular microscope with magnification up to 160x.

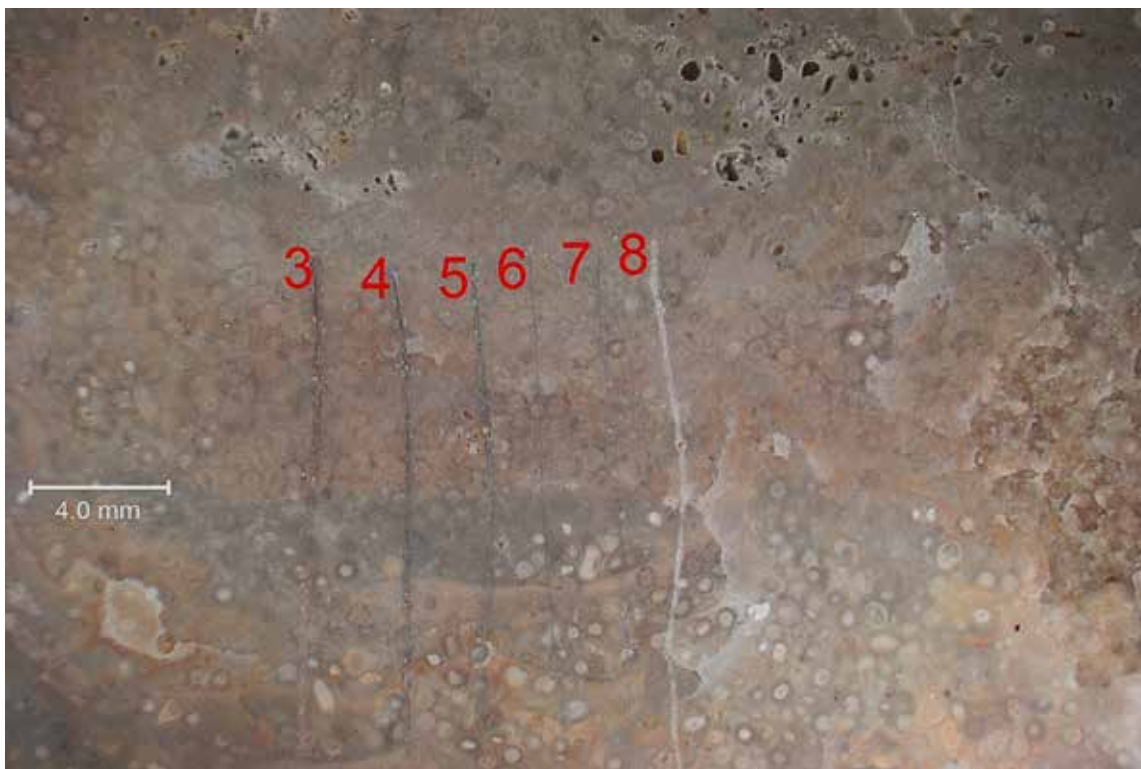
PHOTO: 4

DESCRIPTION: View of the lapped cross section of the stone after Mohs hardness testing. Note that hardness picks 3 thru 7 did not scratch and hardness pick 8 scratched all minerals. The general Mohs hardness would be approximately 7 to 7.5.

1. The overall hardness of the "#16 Butterscotch" stone is approximately 7 to 7.5 on the Mohs scale. The number is based upon testing values of the overall hardness of the rock using Mohs hardness picks.

2. The stones appeared to generally consist of a naturally occurring gravel with siliceous sedimentary rock. A hardness value determination of the stone based upon the mineral assemblage was not conducted. Mohs picks with hardness 3 thru 8 were used on the stone. The Mohs hardness picks determined an approximate overall hardness of 7 to 7.5. This hardness is a more consistent result than using the mineral assemblage because the Mohs hardness picks were drawn directly across a freshly lapped surface of the stone.
