Material Test Report

Report No: MAT:16-03913-S1
Issue No: 1

Client: KAFKA GRANITE, LLC
CC: Jeremy Bores
 John Meyer
Project: 2016 CONSTRUCTION PROJECTS
Job No: 12-02155

Re: Mohs Hardness Testing
2016 Construction Projects
Schofield, WI
AET Project No. 12-02155

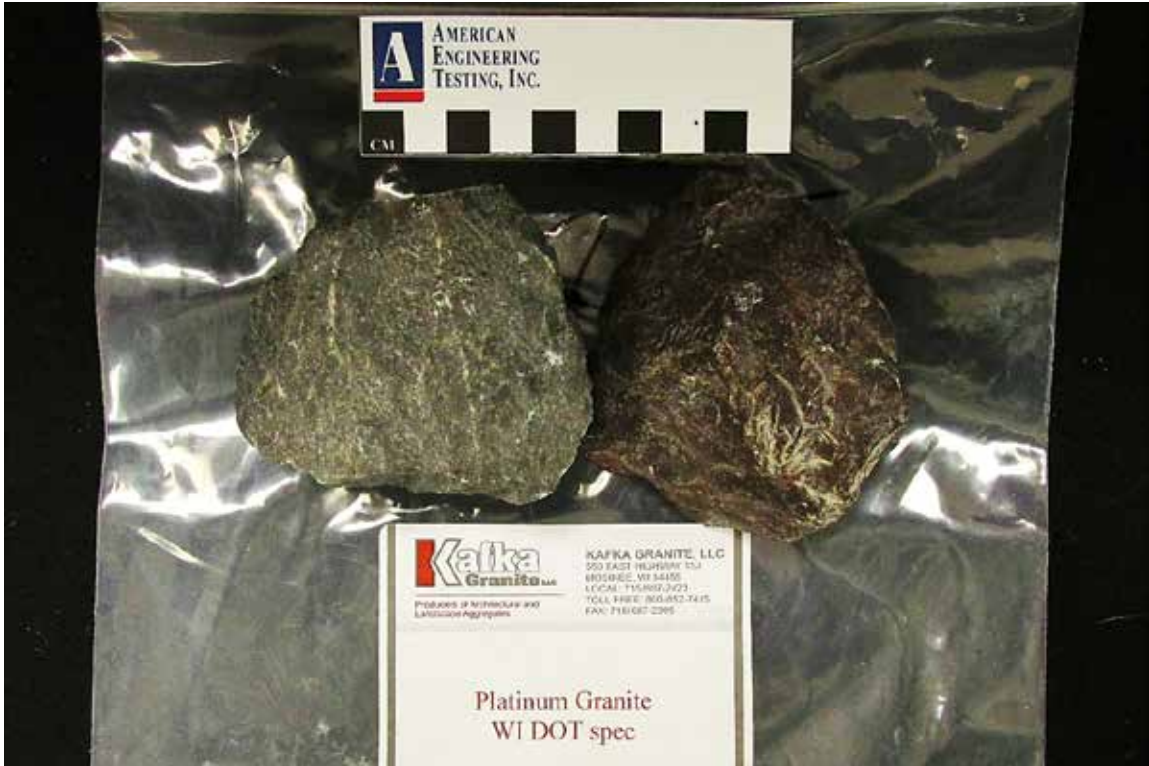
PHOTO: 1

SAMPLE ID: Platinum Granite **DESCRIPTION:** Overall view of the stones as received.

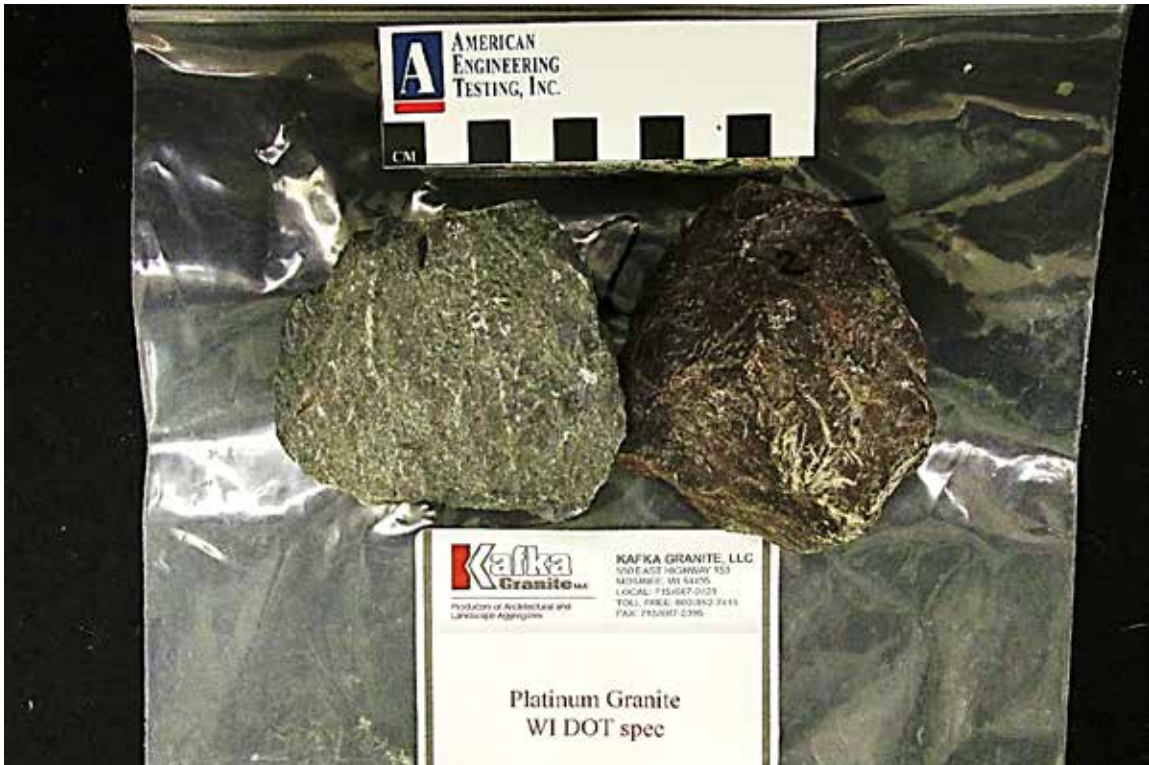
PHOTO: 2

SAMPLE ID: Platinum Granite **DESCRIPTION:** Overall view of the stones after they were labeled with arbitrary numbers for laboratory identification.

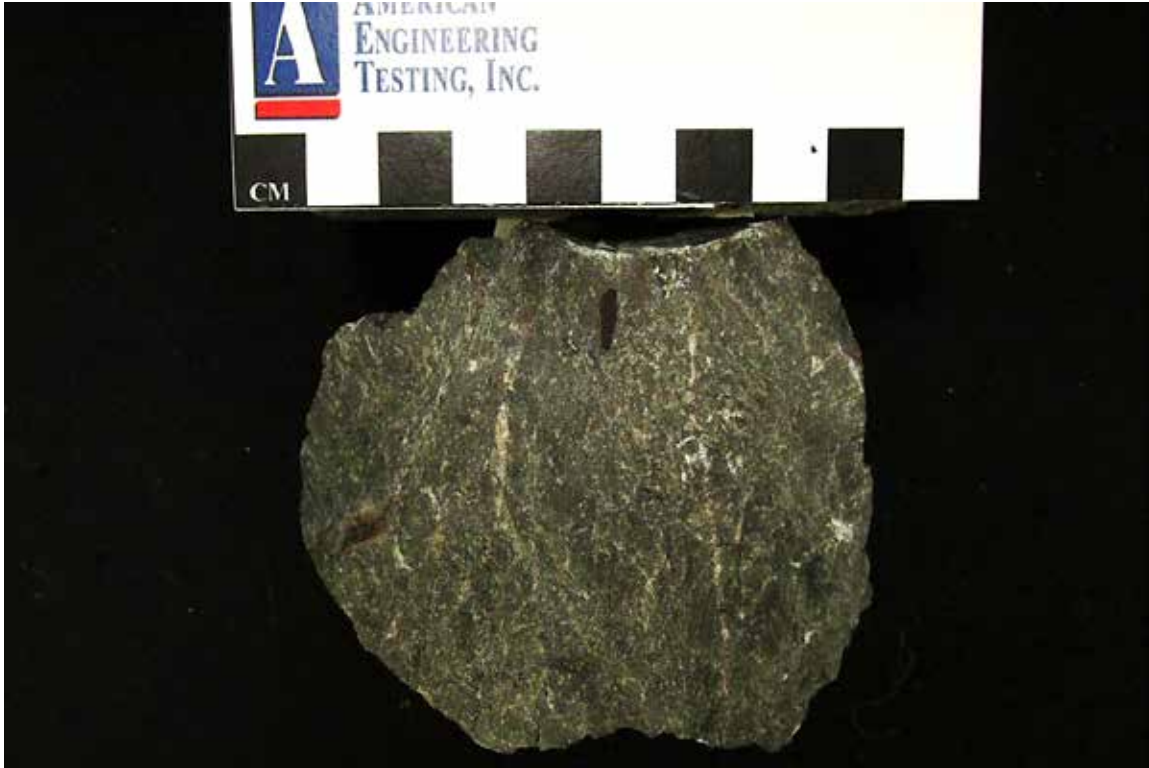
PHOTO: 3

SAMPLE ID: Platinum Granite **DESCRIPTION:** Overall view of the stone before laboratory preparation.
"Stone 1"

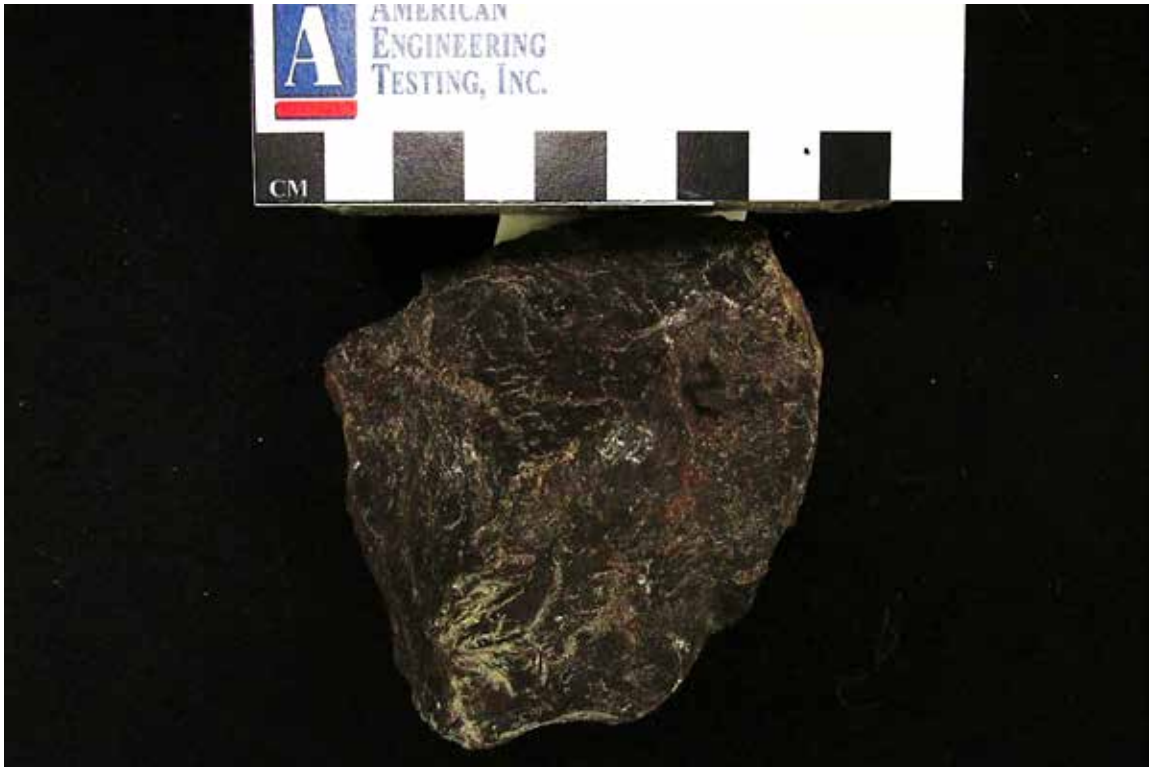
PHOTO: 4

SAMPLE ID: Platinum Granite **DESCRIPTION:** Overall view of the stone before laboratory preparation.
"Stone 2"
