# **Material Test Report**

Project: 2016 CONSTRUCTION PROJECTS

Re: Mohs Hardness Testing 2016 Construction Projects Schofield, WI AET Project No. 12-02155

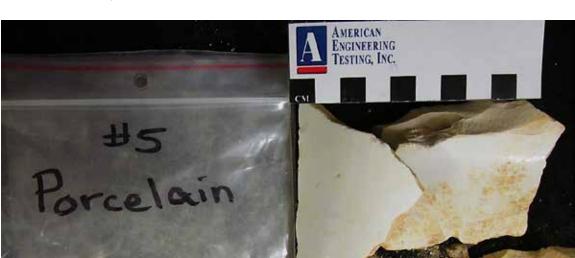
PHOTO: 1

**SAMPLE ID:** #5 Porcelain **DESCRIPTION:** Overall view of the sample as received.

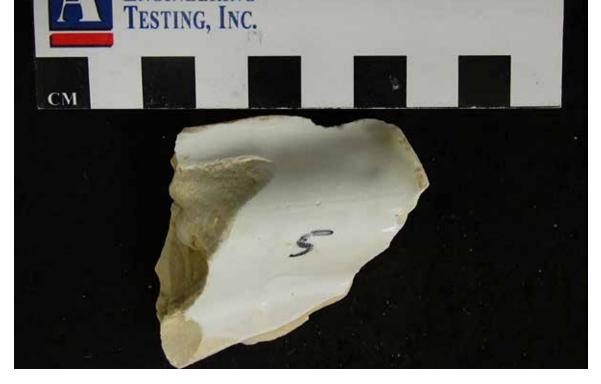
РНОТО: 2

View of the stone selected for hardness testing.

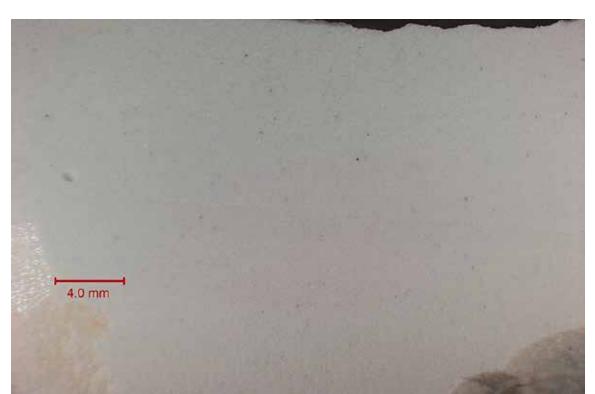
PHOTO: 3

**DESCRIPTION:** View of the lapped cross section of the stone.

Our work was performed on July 26, 2016 and subsequent dates. The hardness testing was completed through the use of standard geologic Mohs hardness points and optical microscopy on a lapped hand sample. The review was performed in general accordance with Standard Operating Procedure 24-LAB-004, "Petrographic Examination of Aggregates for Concrete, ASTM C295." Observations were made using an Olympus SZX-12 stereo-zoom binocular microscope with magnification up to 160x.

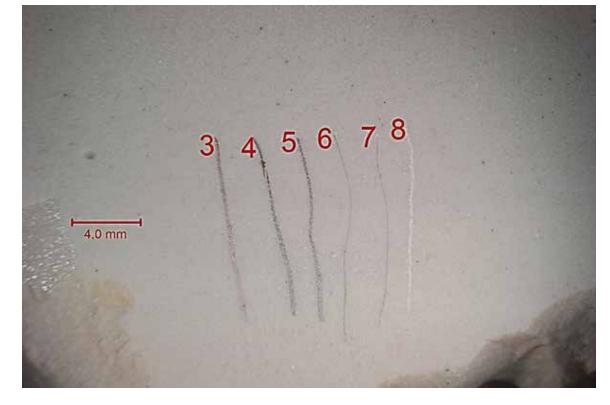
РНОТО: 4

View of the lapped cross section of the stone after Mohs hardness testing. Note **DESCRIPTION:** that hardness picks 3 thru 7 did not scratch and hardness pick 8 scratched all minerals. The general Mohs hardness would be approximately 7.5.

- 1. The overall hardness of the "#5 Porcelain" product is approximately 7.5 on the Mohs scale. The number is based upon testing values of the overall hardness of the porcelain using Mohs hardness picks.

- 2. The product consisted of porcelain fragments. A hardness value determination of the porcelain based upon the material assemblage was not conducted. Mohs picks with hardness 3 thru 8 were used on the porcelain. The Mohs hardness picks determined an approximate overall hardness of 7.5. This hardness is a more consistent result then using the material assemblage because the Mohs hardness picks were drawn directly across a freshly lapped surface of the porcelain.
