# Material Test Report

**Report No: MAT:16-07878-S7**  
**Issue No: 1**

Re: Mohs Hardness Testing  
2016 Construction Projects  
Schofield, WI  
AET Project No. 12-02155

This report presents the results of our Mohs hardness testing of one sample of stone submitted by you on July 20, 2016. The stone is to be referred to as "#7 Rose Pink". Four stones were submitted to our laboratory and one was chosen for testing. The scope of our work in this report was confined to performing Mohs hardness testing on one stone sample.

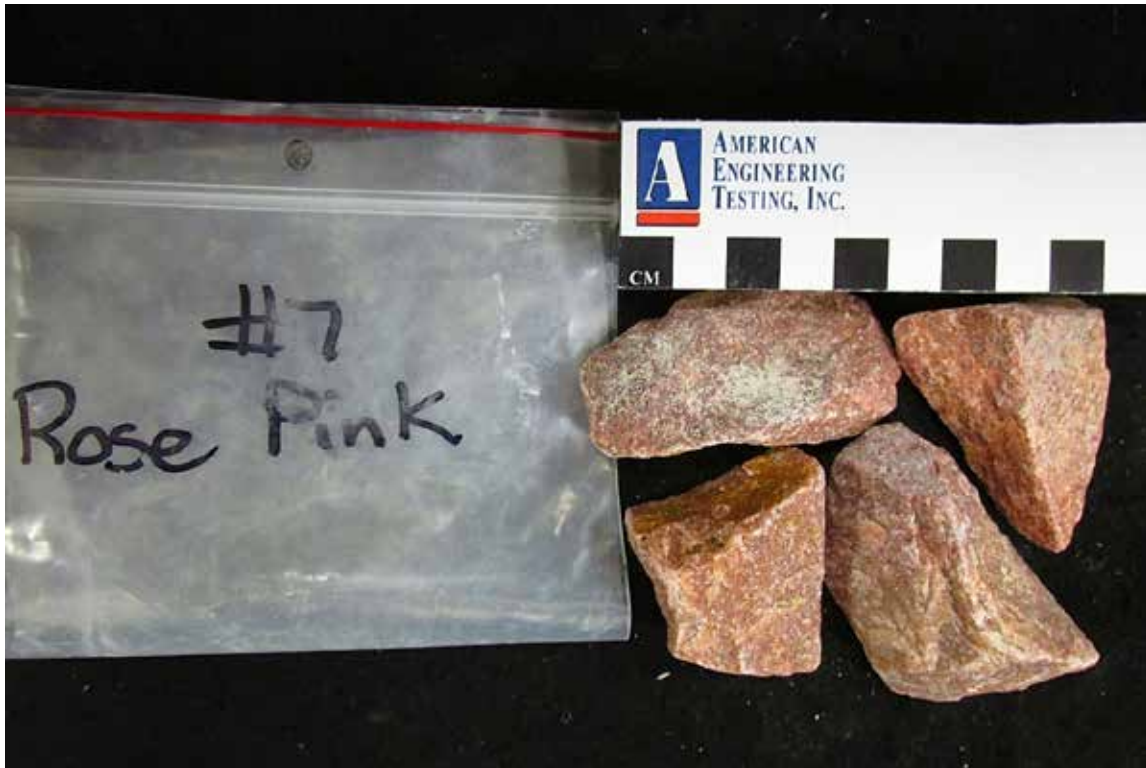
**PHOTO: 1**

**SAMPLE ID:** #7 Rose Pink      **DESCRIPTION:** Overall view of the sample as received.

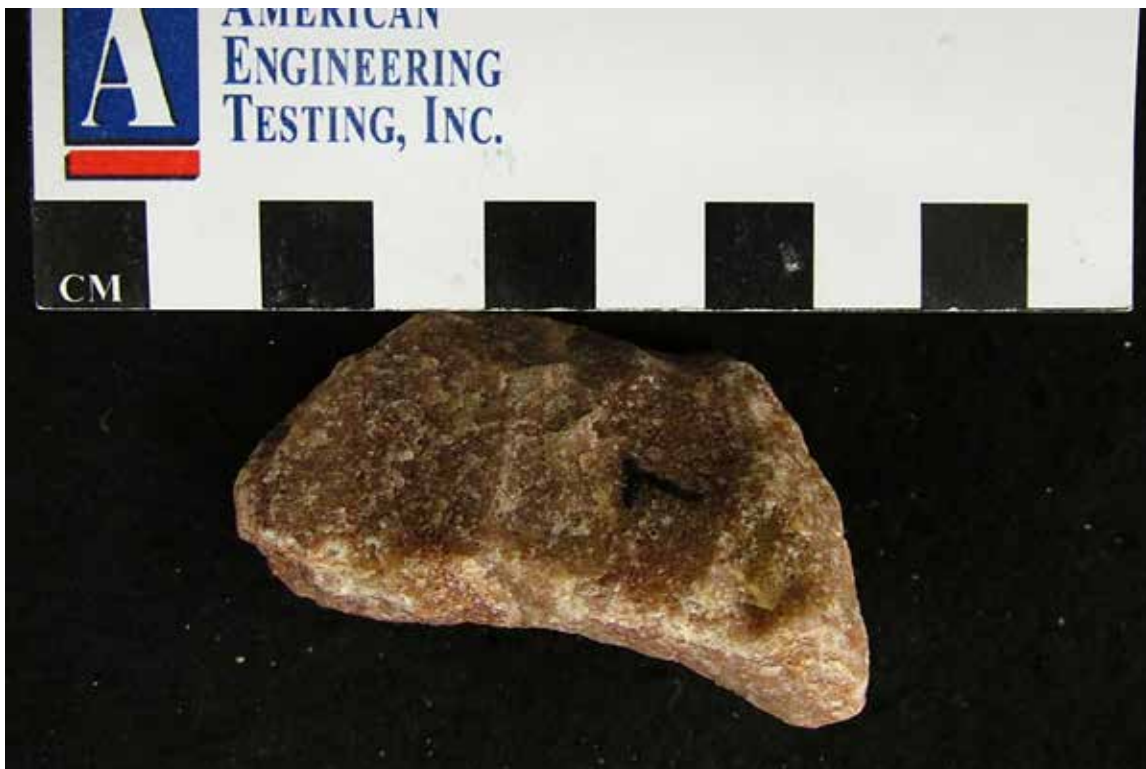
**PHOTO: 2**

**SAMPLE ID:** #7 Rose Pink      **DESCRIPTION:** View of the stone selected for hardness testing.

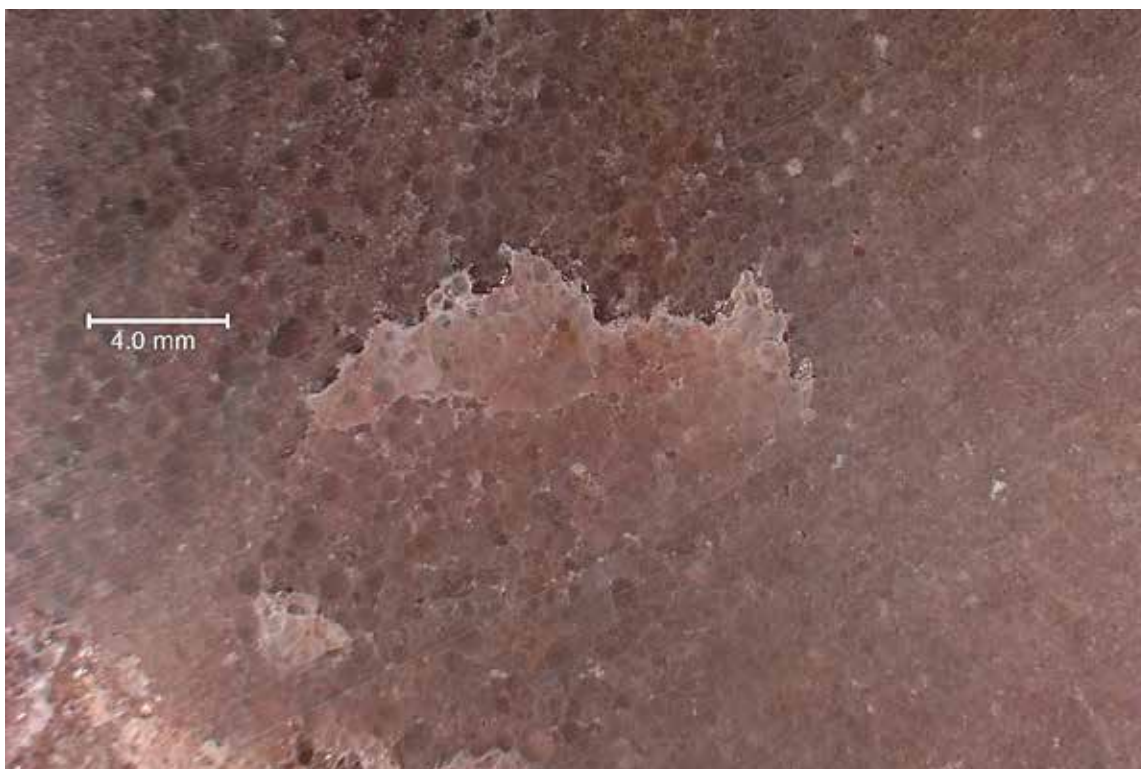
**PHOTO: 3**

#7 Rose Pink  
5x

**DESCRIPTION:** View of the lapped cross section of the stone.

Our work was performed on July 26, 2016 and subsequent dates. The hardness testing was completed through the use of standard geologic Mohs hardness points and optical microscopy on a lapped hand sample. The review was performed in general accordance with Standard Operating Procedure 24-LAB-004, "Petrographic Examination of Aggregates for Concrete, ASTM C295." Observations were made using an Olympus SZX-12 stereo-zoom binocular microscope with magnification up to 160x.

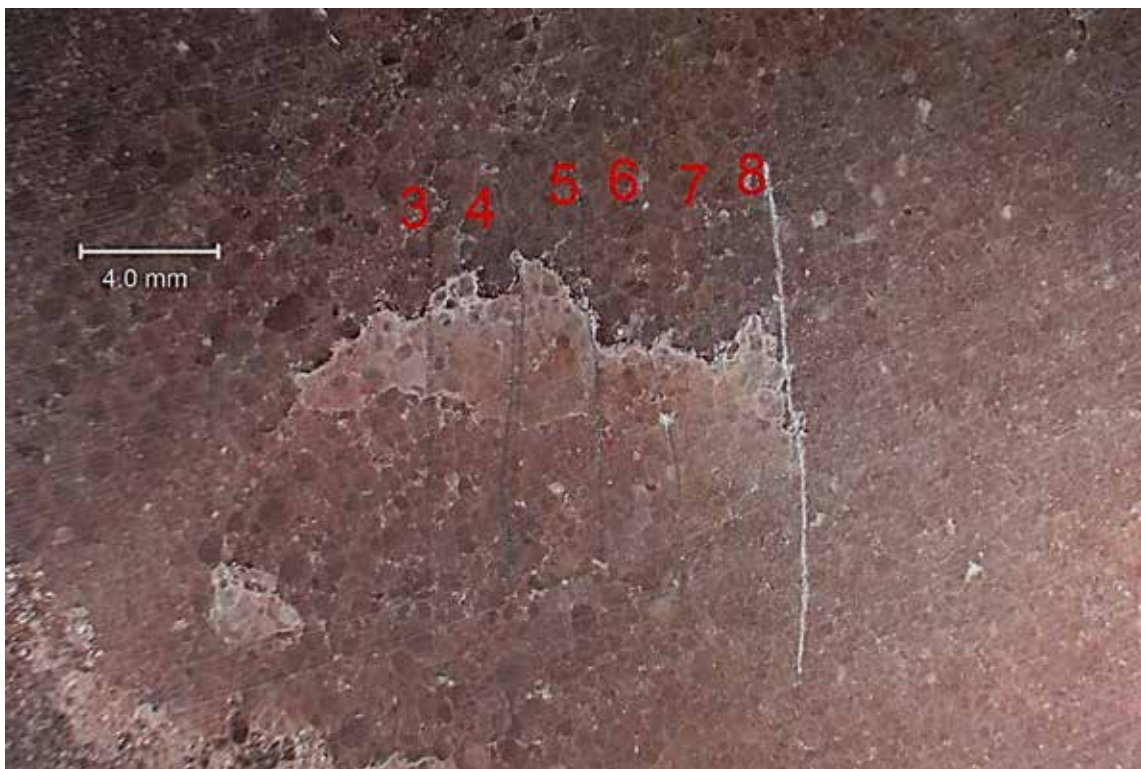
**PHOTO: 4**

#7 Rose Pink  
5x

**DESCRIPTION:** View of the lapped cross section of the stone after Mohs hardness testing. Note that hardness picks 3 thru 7 did not scratch and hardness pick 8 scratched all minerals. The general Mohs hardness would be approximately 7.5.

1. The overall hardness of the "#7 Rose Pink" stone is approximately 7.5 on the Mohs scale. The number is based upon testing values of the overall hardness of the rock using Mohs hardness picks.

2. The stone appeared to generally consist of a fine grained, metamorphic rock. A hardness value determination of the stone based upon the mineral assemblage was not conducted. Mohs picks with hardness 3 thru 8 were used on the stone. The Mohs hardness picks determined an approximate overall hardness of 7.5. This hardness is a more consistent result than using the mineral assemblage because the Mohs hardness picks were drawn directly across a freshly lapped surface of the stone.
