Material Test Report

Report No: MAT:16-07878-S21
Issue No: 1

Re: Mohs Hardness Testing
2016 Construction Projects
Schofield, WI
AET Project No. 12-02155

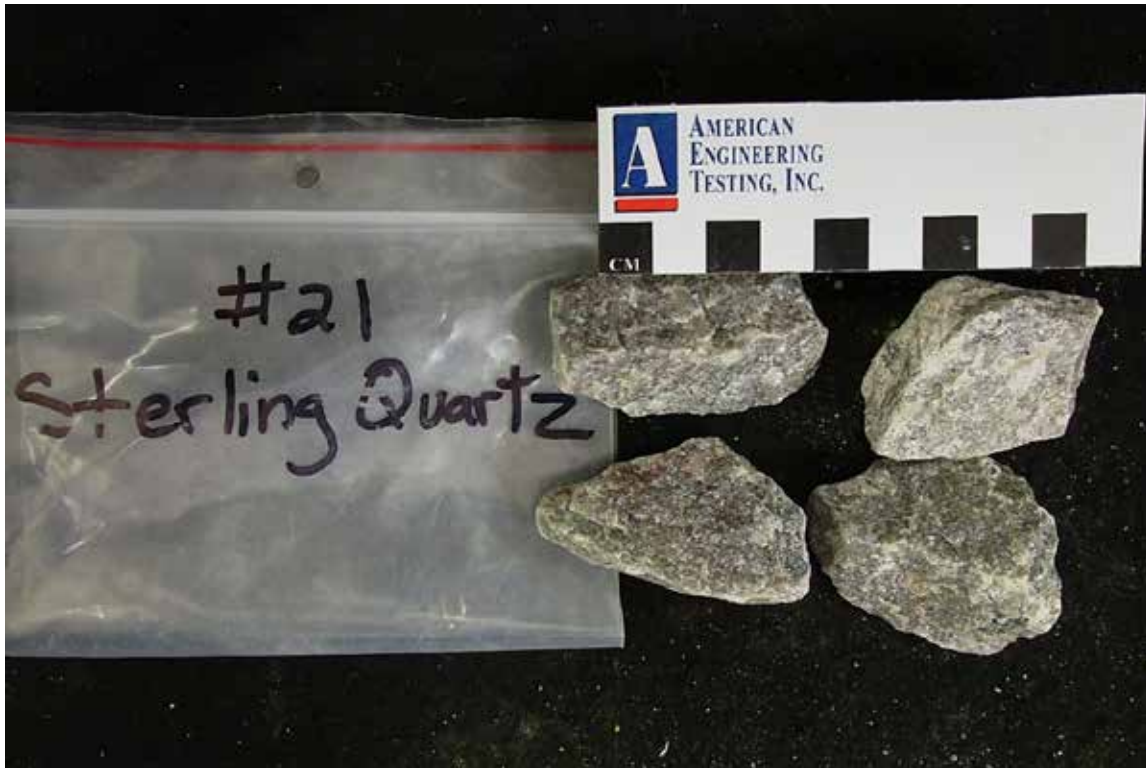
PHOTO: 1

SAMPLE ID: #21 Sterling Quartz **DESCRIPTION:** Overall view of the sample as received.

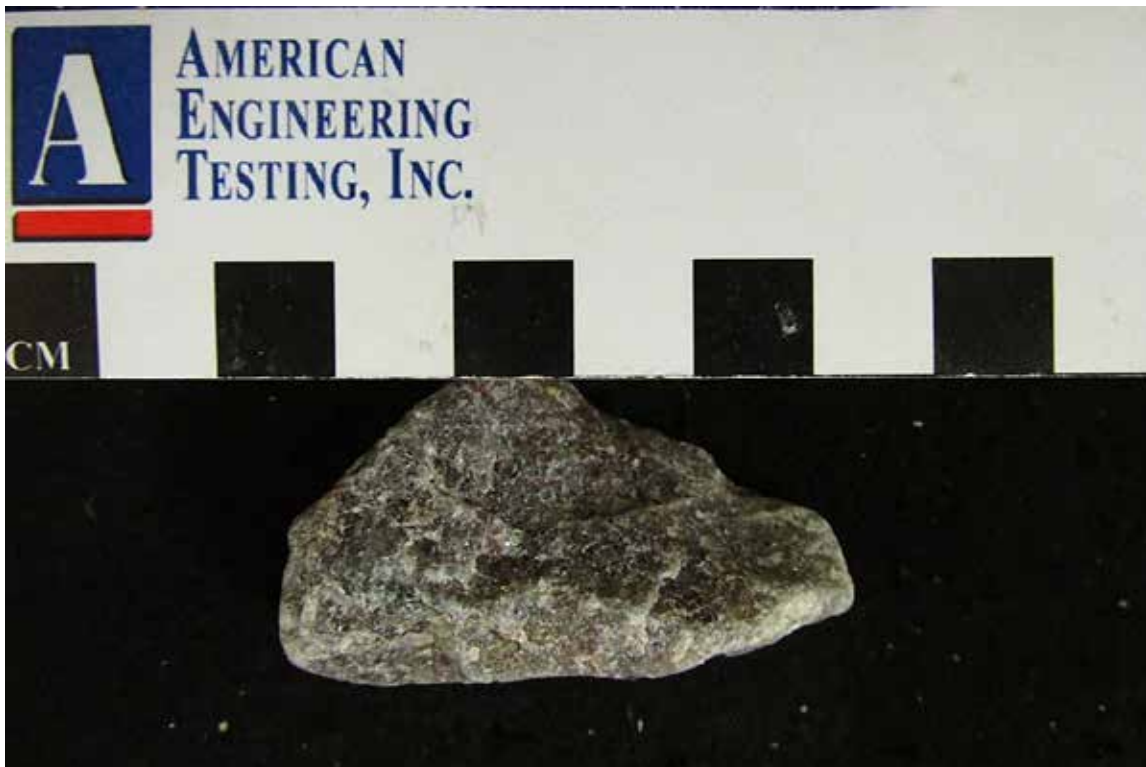
PHOTO: 2

SAMPLE ID: #21 Sterling Quartz **DESCRIPTION:** View of the stone selected for hardness testing.

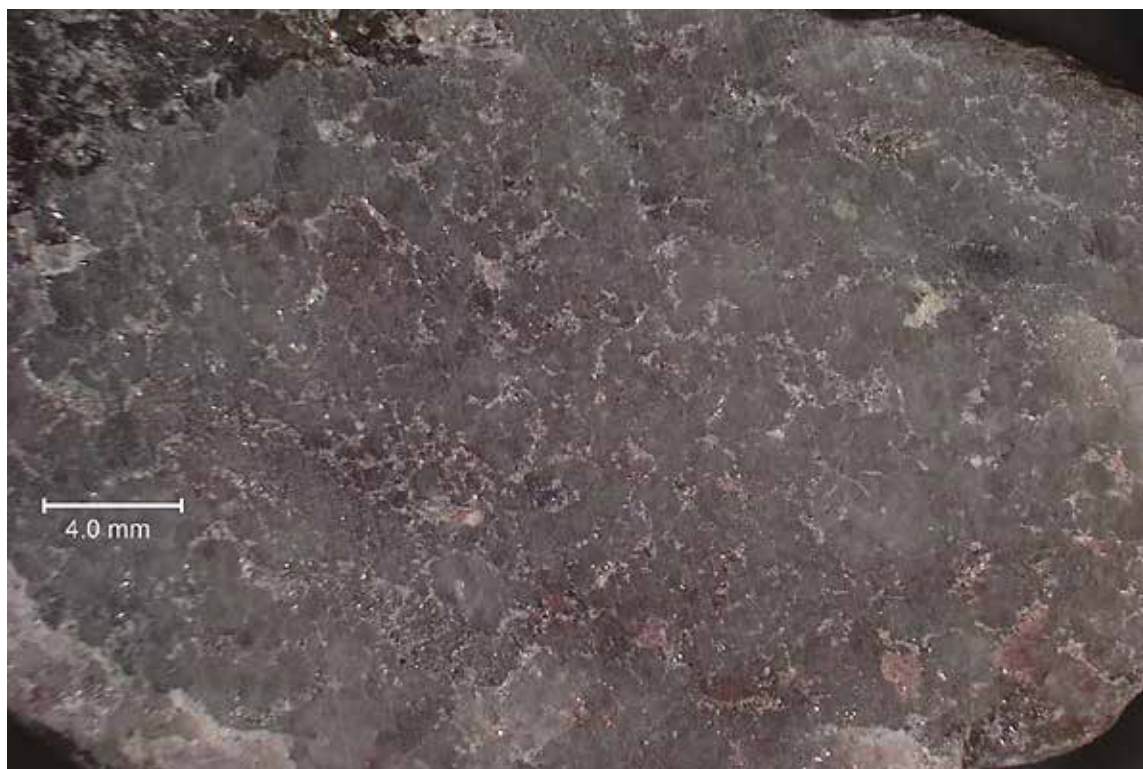
PHOTO: 3

SAMPLE ID: #21 Sterling Quartz
MAG: 5x
DESCRIPTION: View of the lapped cross section of the stone.
