Report No: MAT:AET-132451-S1

Material Test Report

Project: Kafka Granite 2023 Construction Projects

RE: Kafka Granite 2023 Construction Projects
AET Report No. P-0021353

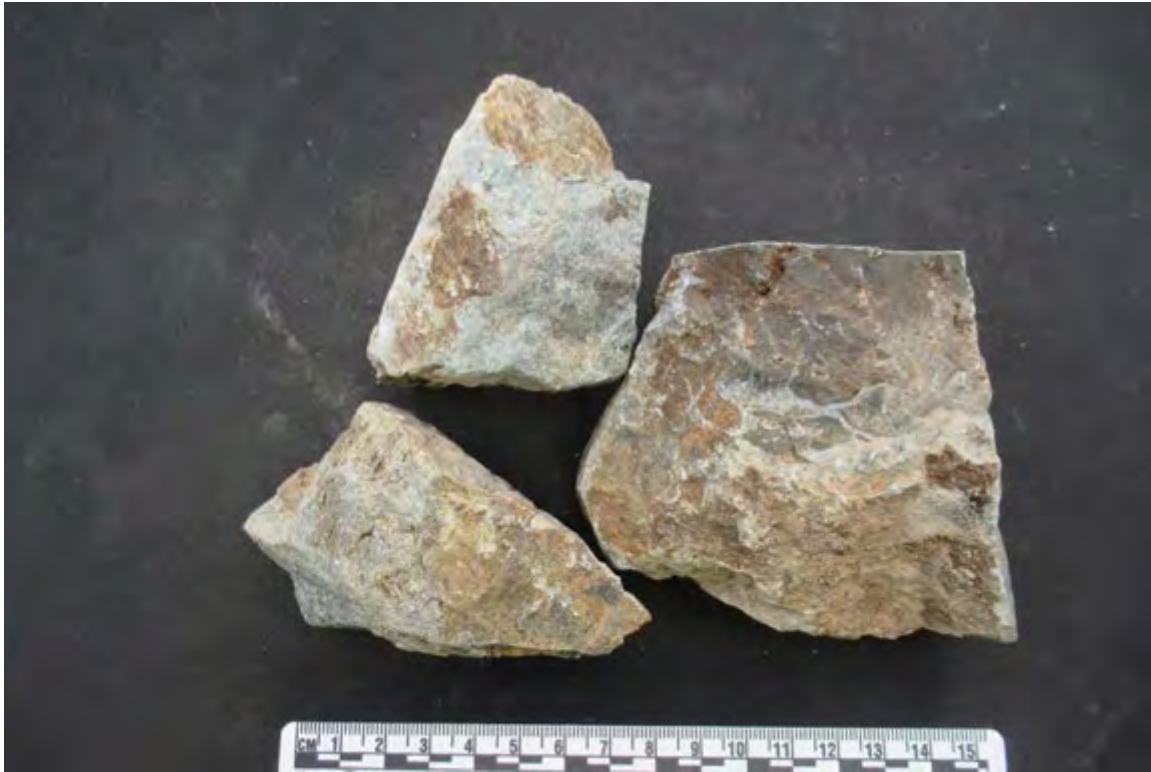
Photo: 1

Description: Overall view of the sample as received.

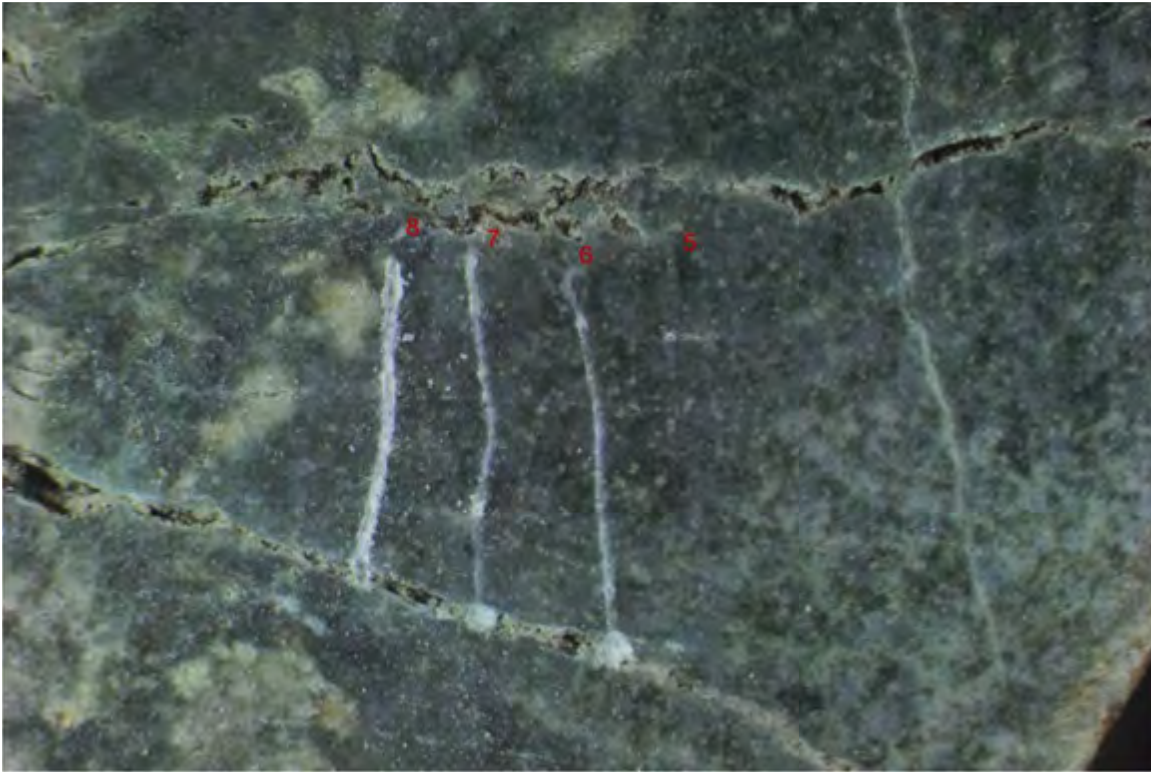
Photo: 3

Description: View of a tested particle. It was not scratched by a pick with a hardness below a 7. The overall hardness was 7 – 8.

1. The overall hardness of the "Jade" aggregate is approximately 7 on the Mohs scale. This number is based upon testing values of the overall hardness of 3 selected rocks using Mohs hardness picks of 2, 3, 4, 5, 6, 7, and 8. The average hardness of the three particles was then calculated. The hardness values of the individual rocks were as follows:

Mohs Hardness	3 – 4	4 – 5	5 – 6	6 – 7	7 – 8
Number of Rocks	0	0	0	1	2

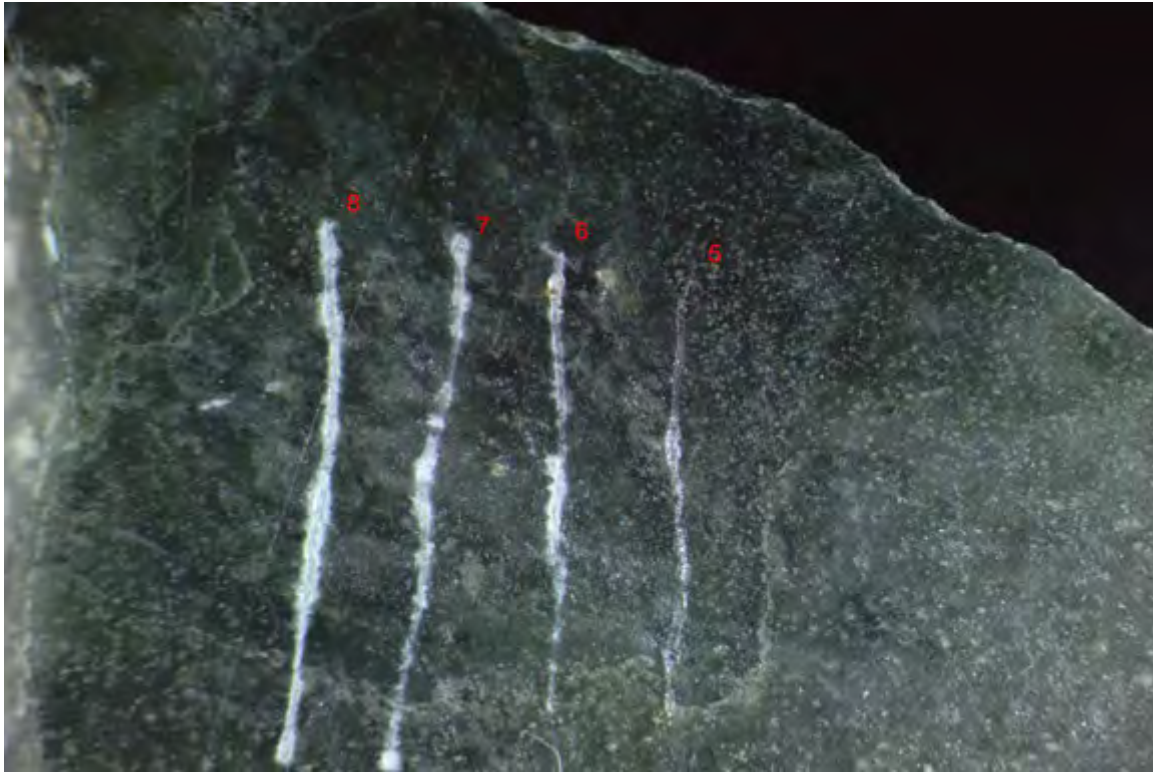
Photo: 5

Description: View of a tested particle. It was not scratched by a pick with a hardness below a 6. The overall hardness was 6 – 7.

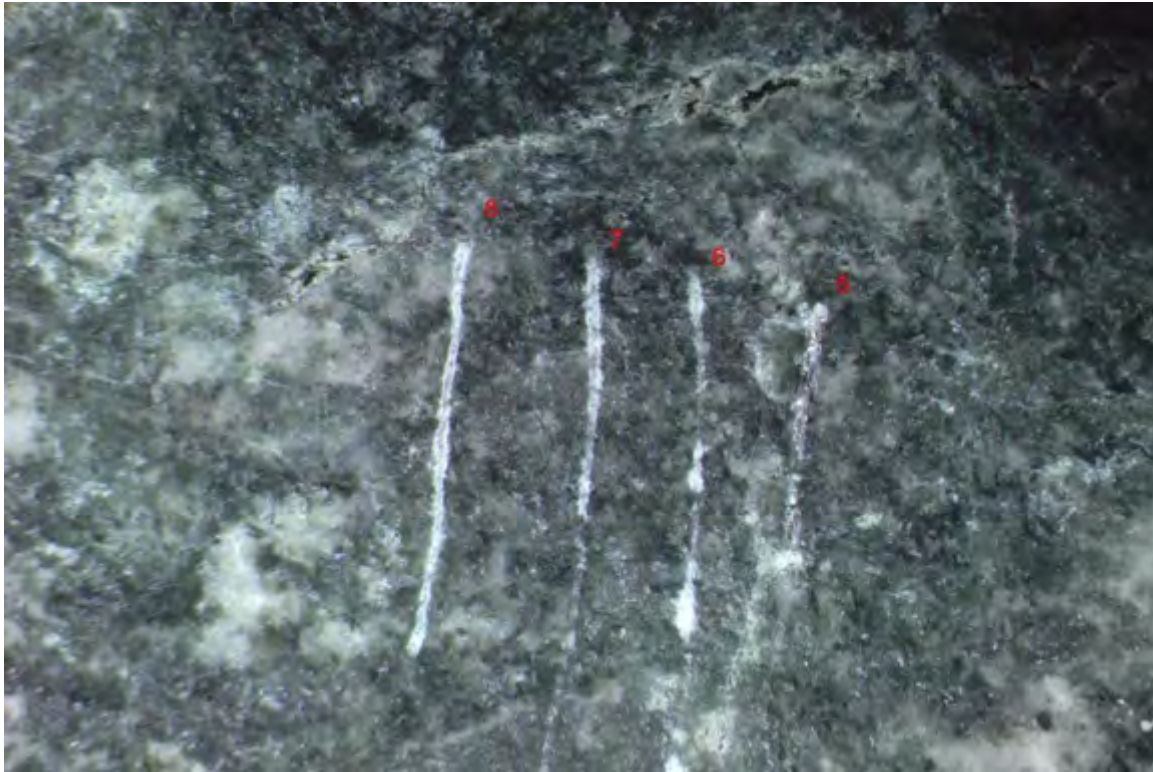
Photo: 7

Description: View of a tested particle. It was not scratched by a pick below 6. The #6 pick only scratched a few minerals in the rock. The overall hardness was 7 – 8.

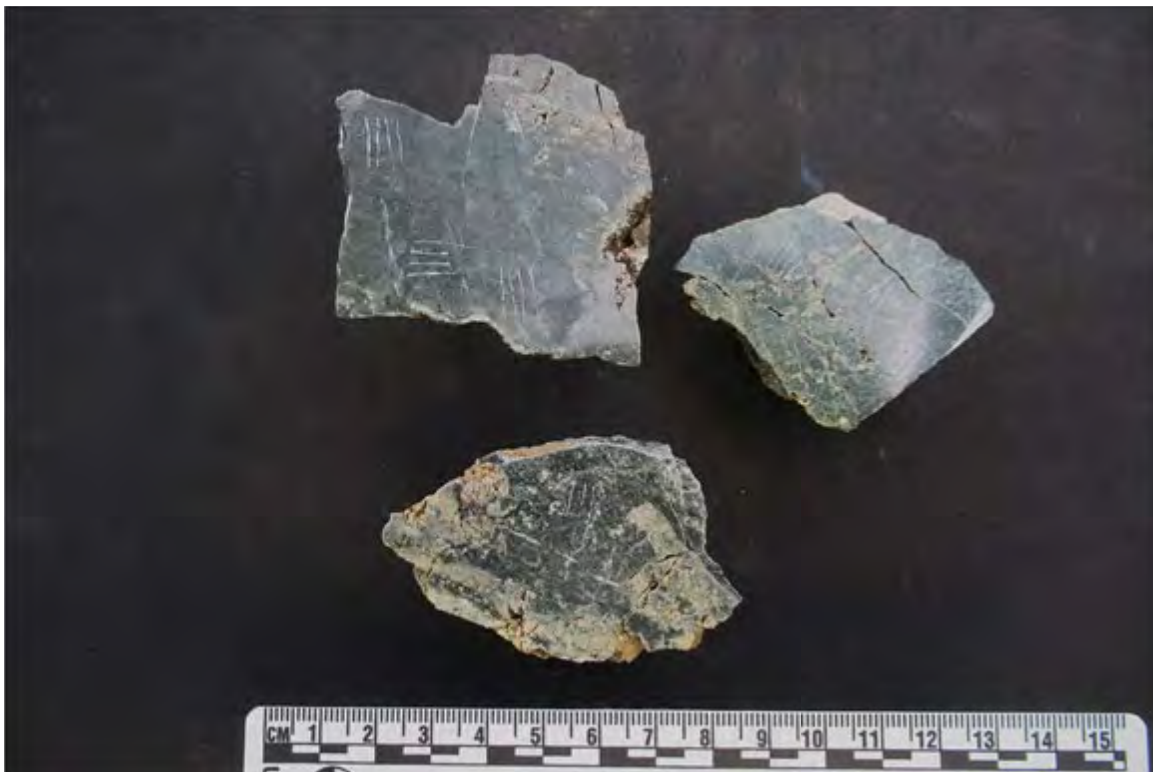
Photo: 8

Description: View of the rocks after being tested. Note that each rock was tested three different places and orientations and results were averaged.

2. The aggregate was a crushed product, and the particles were generally angular in shape. A Mohs pick with hardness of 8 was used on the three particles. If the Mohs 8 pick scratched a particle, then the next Mohs pick with a lesser hardness was used until the particle would not scratch. The Mohs hardness picks were drawn directly across a freshly lapped surface of the particles.
