Material Test Report

Report No: MAT:AET-154226-S1
Issue No: 1

Project: Kafka 2024 Construction Projects

RE: Kafka Granite 2024 Construction Projects
AET Report No. P-0029805

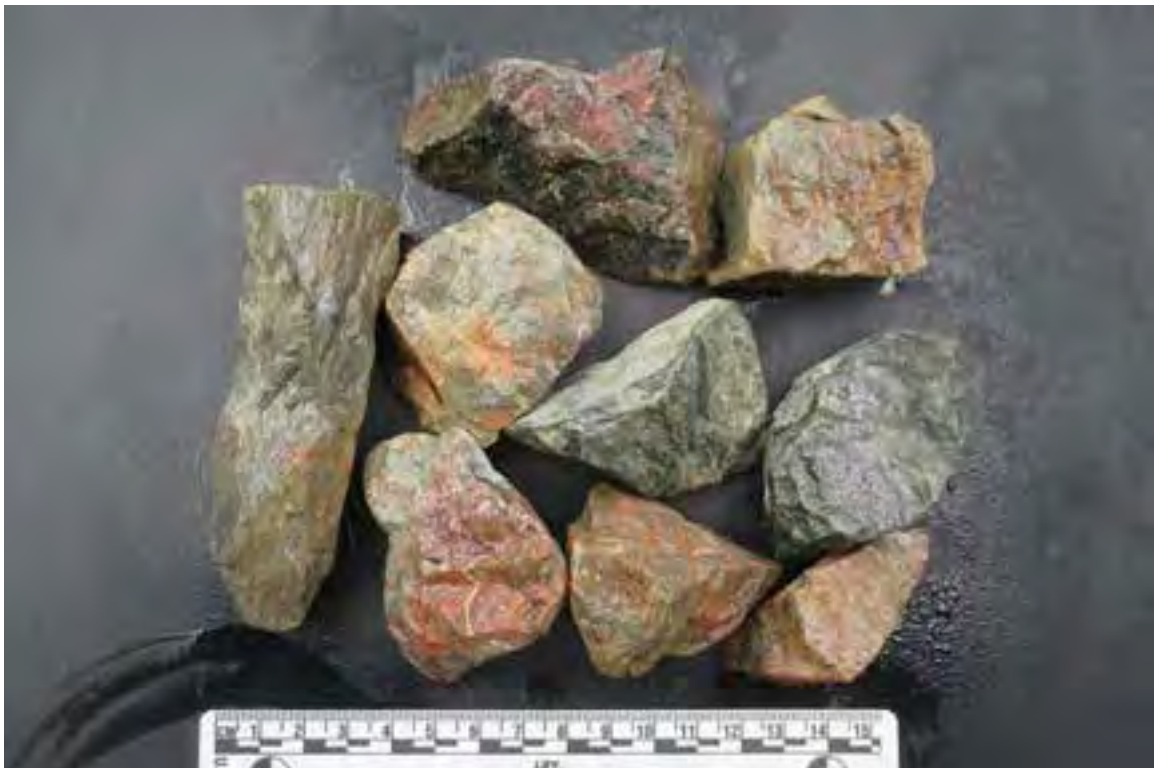
Photo: 2

Description: Overall view of the sample particles.

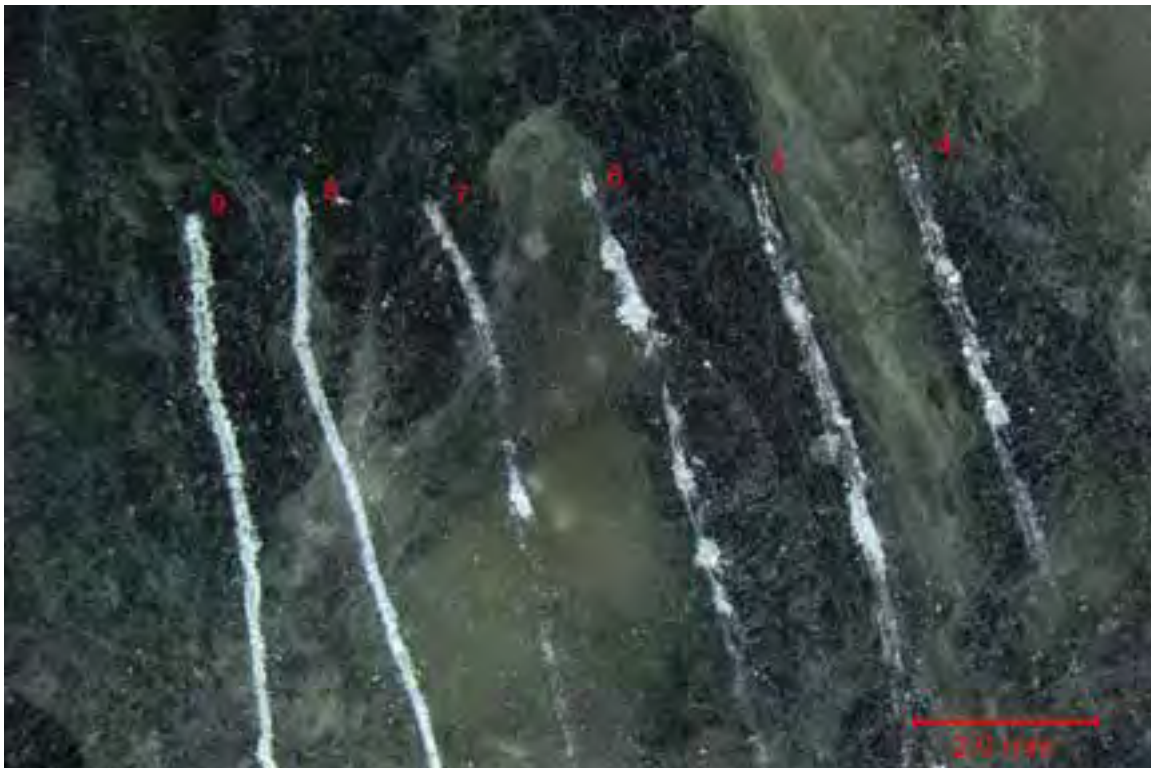
Photo: 4

Rock 1
10x

Description: View of the lapped cross sections of the rocks after Mohs hardness testing under magnification and reflected light. The overall hardness of the rock was 6 – 7.

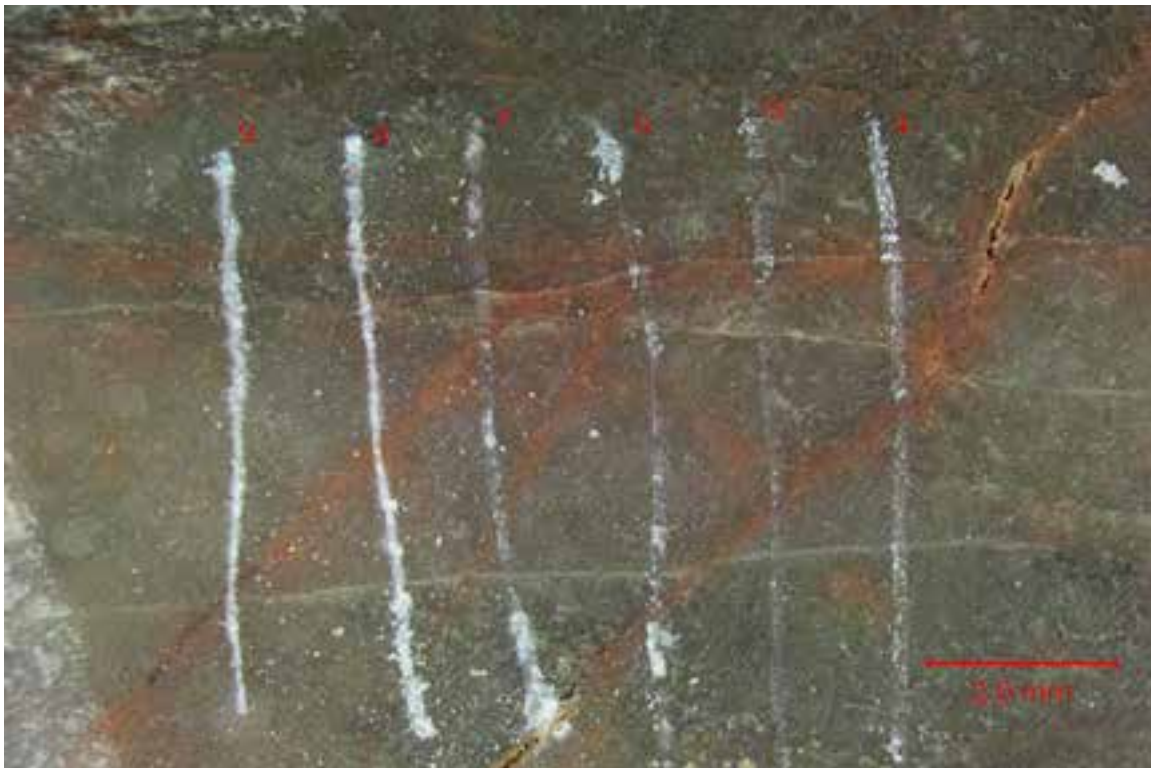
Photo: 6

Rock 2
10x

Description: View of the lapped cross sections of the rocks after Mohs hardness testing under magnification and reflected light. The overall hardness of the rock was 6 – 7.

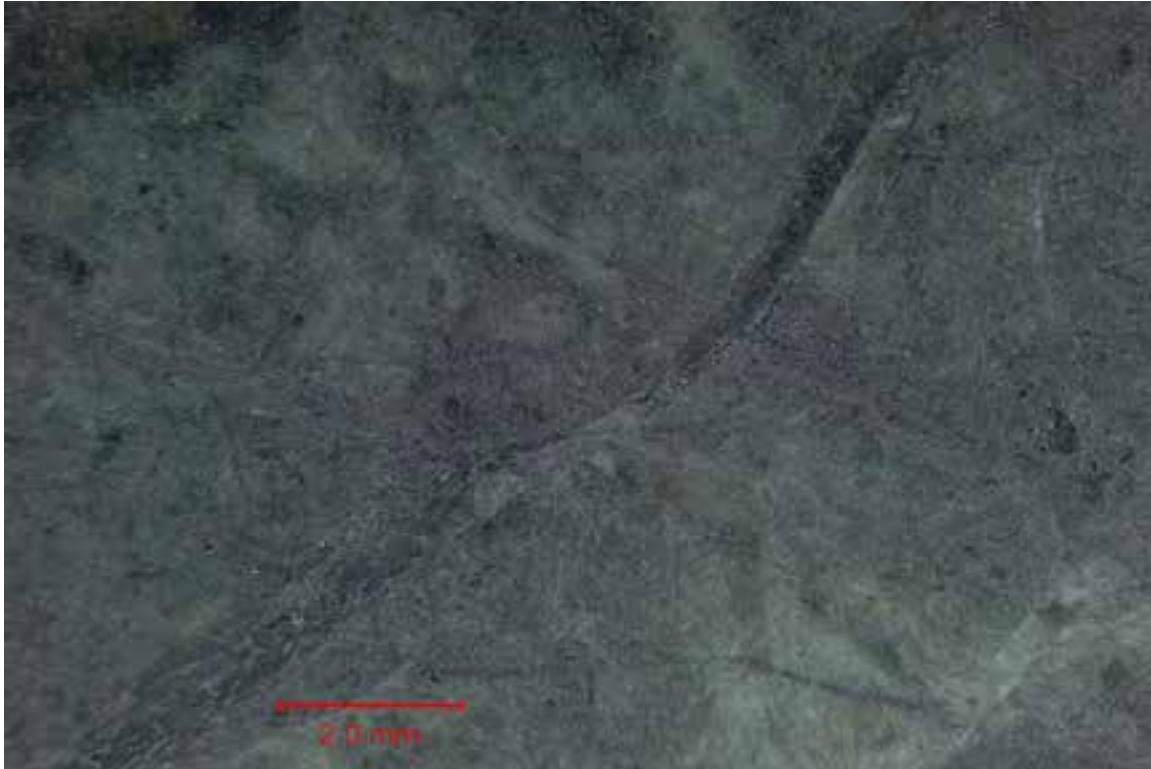
Photo: 7

Rock 3
10x

Description: View of the lapped cross section of the rock under magnification and reflected light.

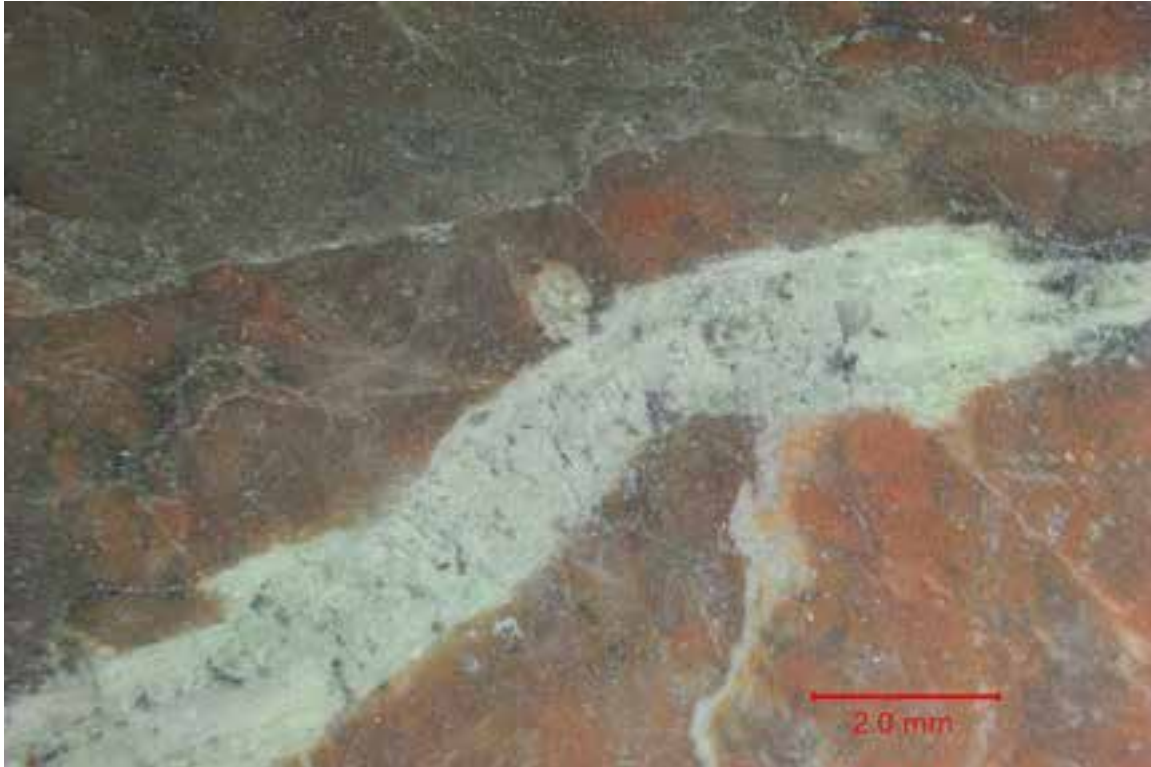
Photo: 9

Rock 4
10x

Description: View of the lapped cross section of the rock under magnification and reflected light.

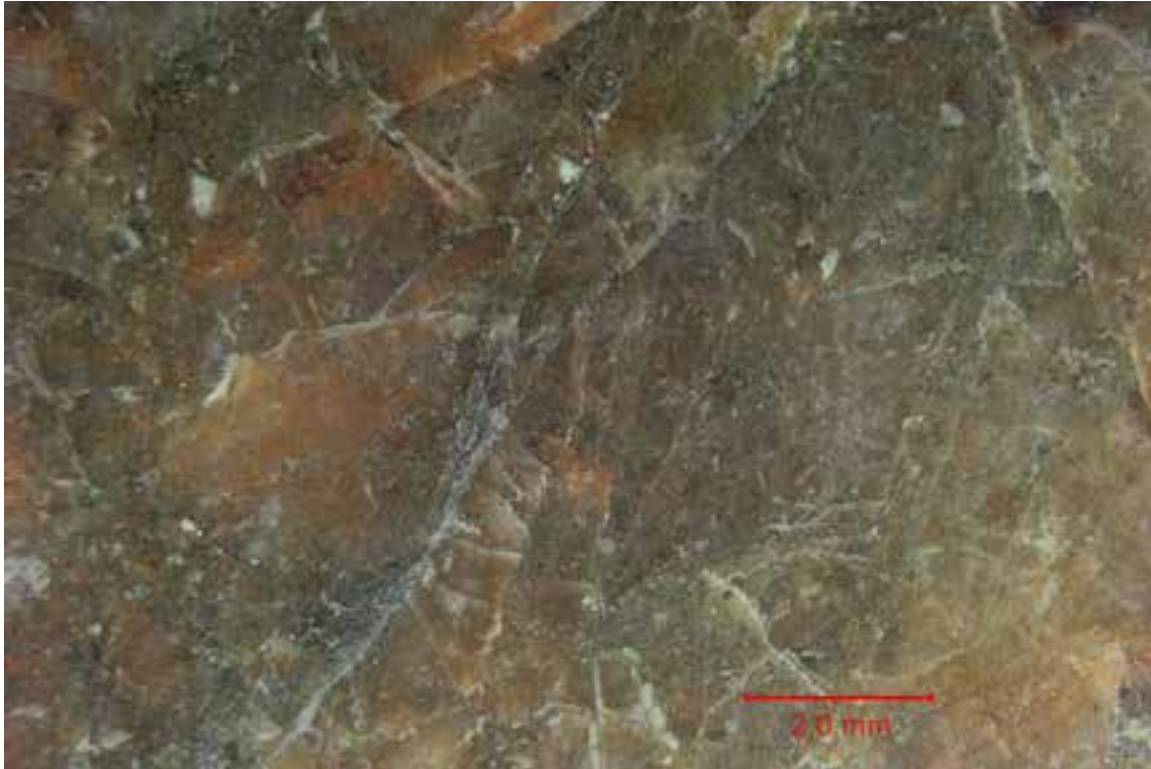
Photo: 11

Rock 5
10x

Description: View of the lapped cross section of the rock under magnification and reflected light.

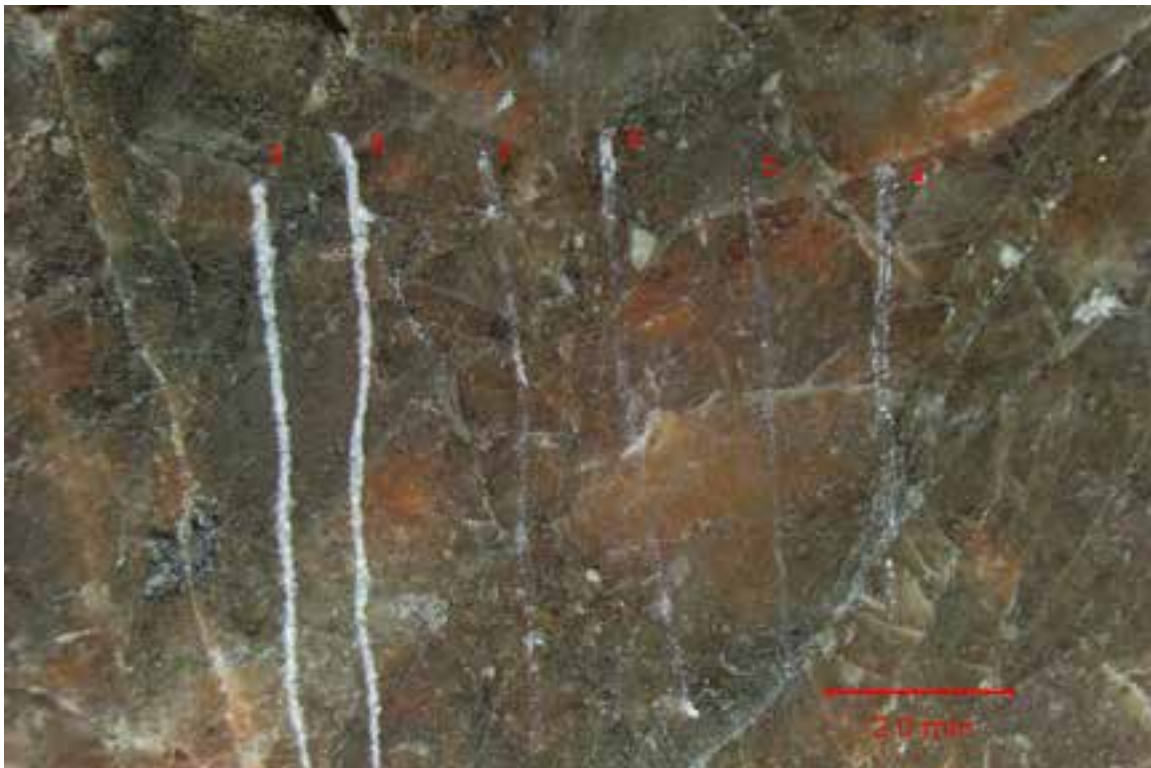
Photo: 12

Rock 5
10x

Description: View of the lapped cross sections of the rocks after Mohs hardness testing under magnification and reflected light. The overall hardness of the rock was 7 – 8.
