Material Test Report

Report No: MAT:AET-132451-S2

Project: Kafka Granite 2023 Construction Projects

Date Sampled9/15/2023SourceKafka GraniteMaterial3/8" x 1/8" PatinaSpecificationASTM:C127Sampling MethodSampled by ClientGeneral LocationMarathon County, WILocationKafka Granite Stockpile

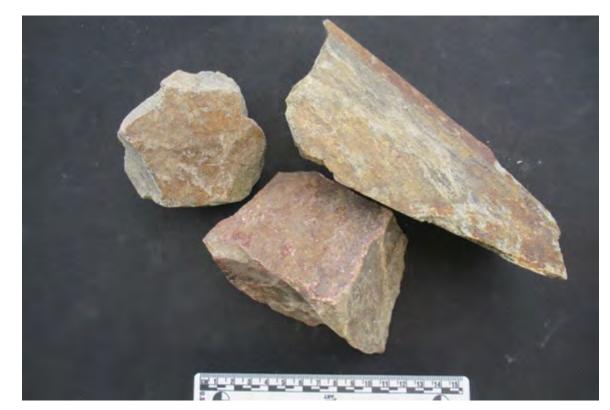
Photo: 1

Description: Overall view of the sample as received.

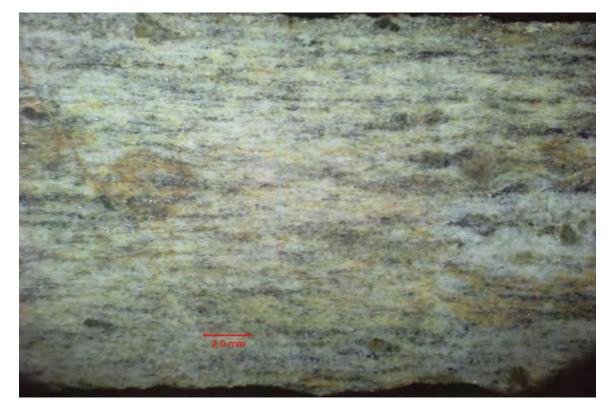
Photo: 2

Sample ID: Mag: Patina 1 5x **Description:** View of the rock after being saw cut and polished.

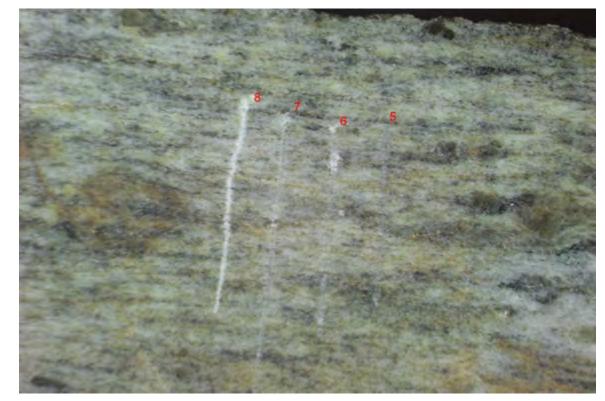
Photo: 3

Patina 1 7.5x **Description:** View of a tested particle. It was not scratched by a pick with a hardness below a 7. The overall hardness was 7 - 8.

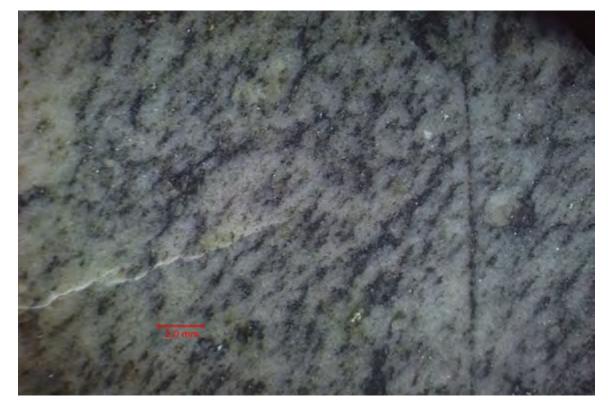
Photo: 4

Patina 2 5x **Description:** View of the rock after being saw cut and polished.

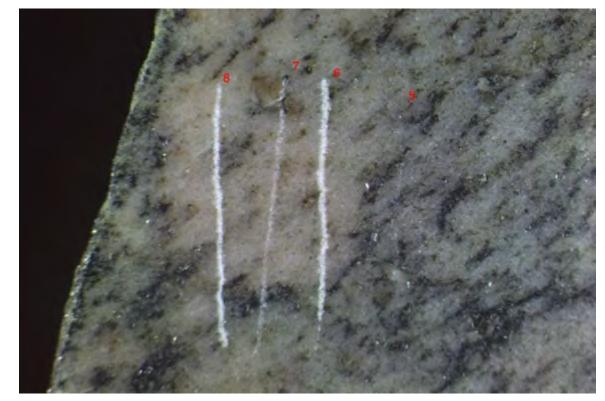
Photo: 5

Patina 2 7.5x **Description:** View of a tested particle. It was not scratched by a pick with a hardness below a 6. The overall hardness was 6-7.

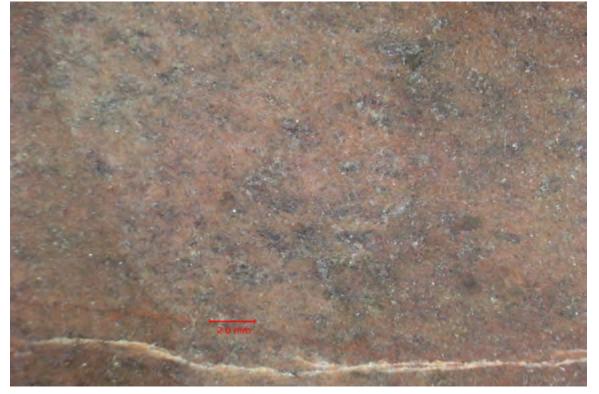
Photo: 6

Patina 3 5x **Description:** View of the rock after being saw cut and polished.

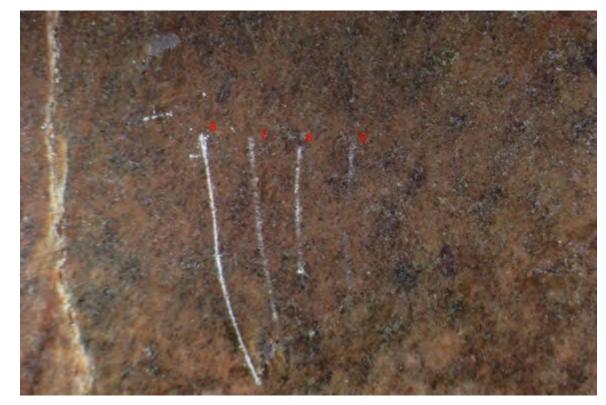
Photo: 7

Patina 3 7.5x **Description:** View of a tested particle. It was not scratched by a pick with a hardness below a 7. The overall hardness was 7 - 8.
