# Material Test Report

**Report No: MAT:16-07878-S6**  
**Issue No: 1**

Re: Mohs Hardness Testing  
2016 Construction Projects  
Schofield, WI  
AET Project No. 12-02155

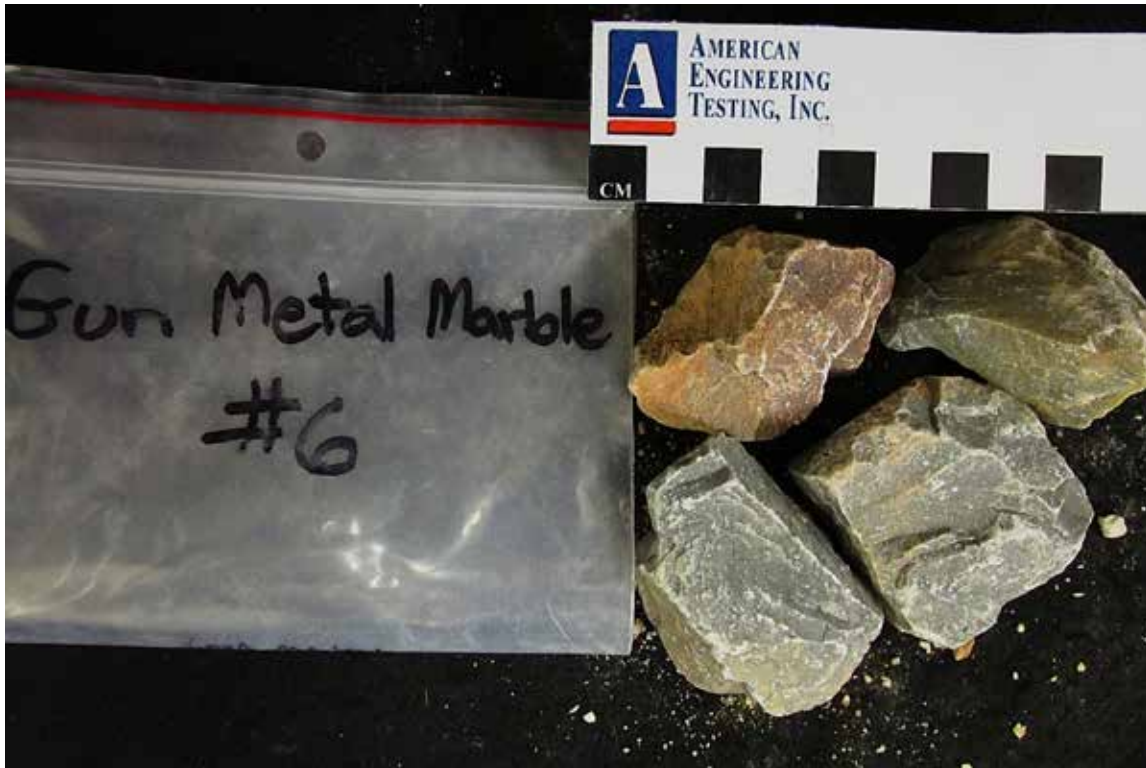
**PHOTO: 1**

**SAMPLE ID:** #6 Gun Metal Marble      **DESCRIPTION:** Overall view of the sample as received.

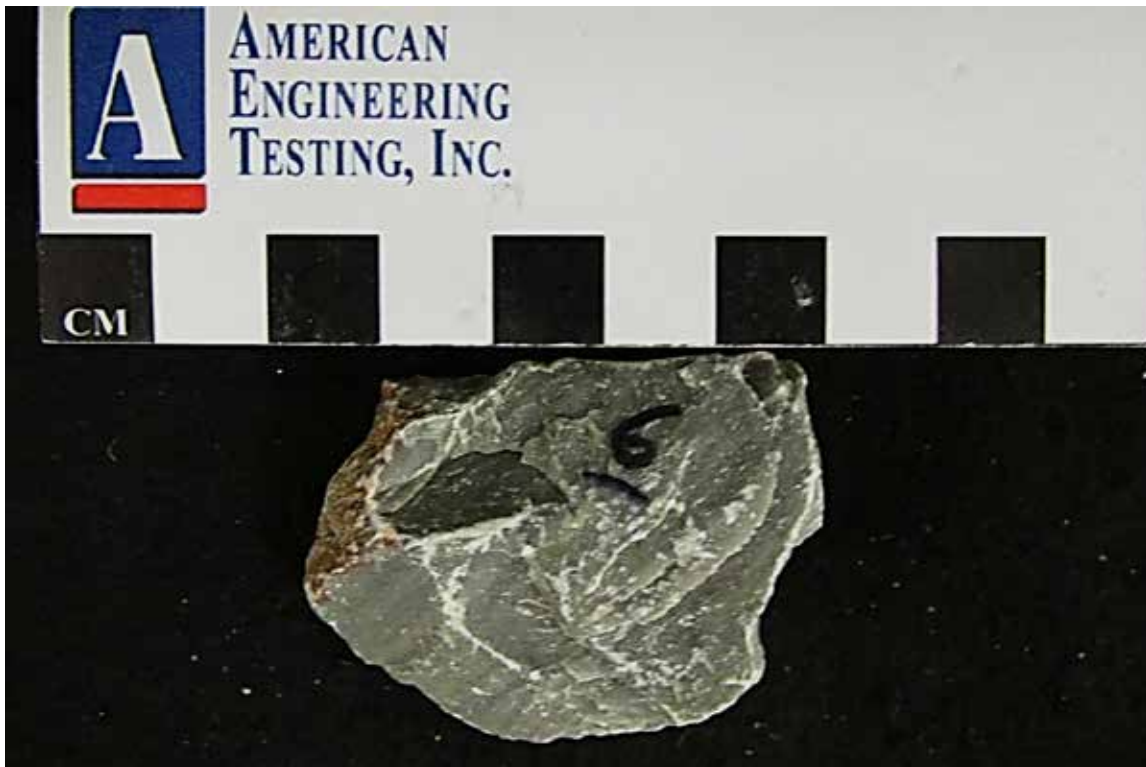
**PHOTO: 2**

**SAMPLE ID:** #6 Gun Metal Marble      **DESCRIPTION:** View of the stone selected for hardness testing.

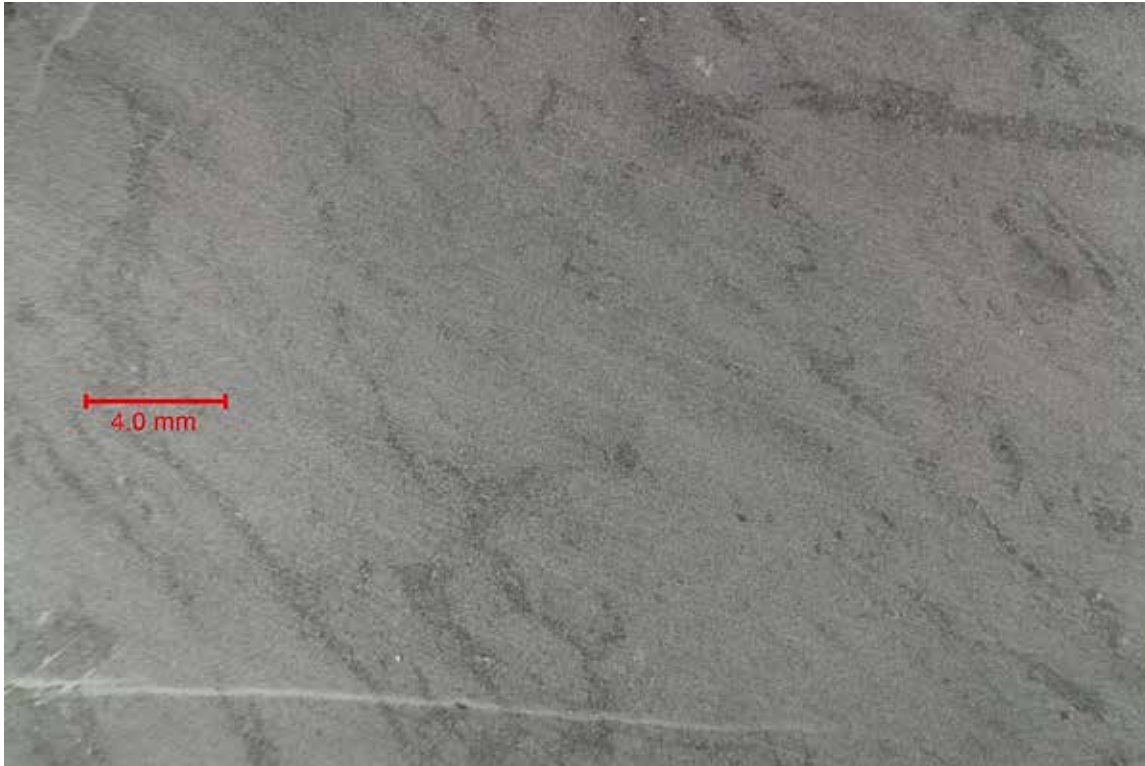
**PHOTO: 3**

**SAMPLE ID:** #6 Gun Metal Marble  
**MAG:** 5x

**DESCRIPTION:** View of the lapped cross section of the stone.

Our work was performed on July 26, 2016 and subsequent dates. The hardness testing was completed through the use of standard geologic Mohs hardness points and optical microscopy on a lapped hand sample. The review was performed in general accordance with Standard Operating Procedure 24-LAB-004, "Petrographic Examination of Aggregates for Concrete, ASTM C295." Observations were made using an Olympus SZX-12 stereo-zoom binocular microscope with magnification up to 160x.

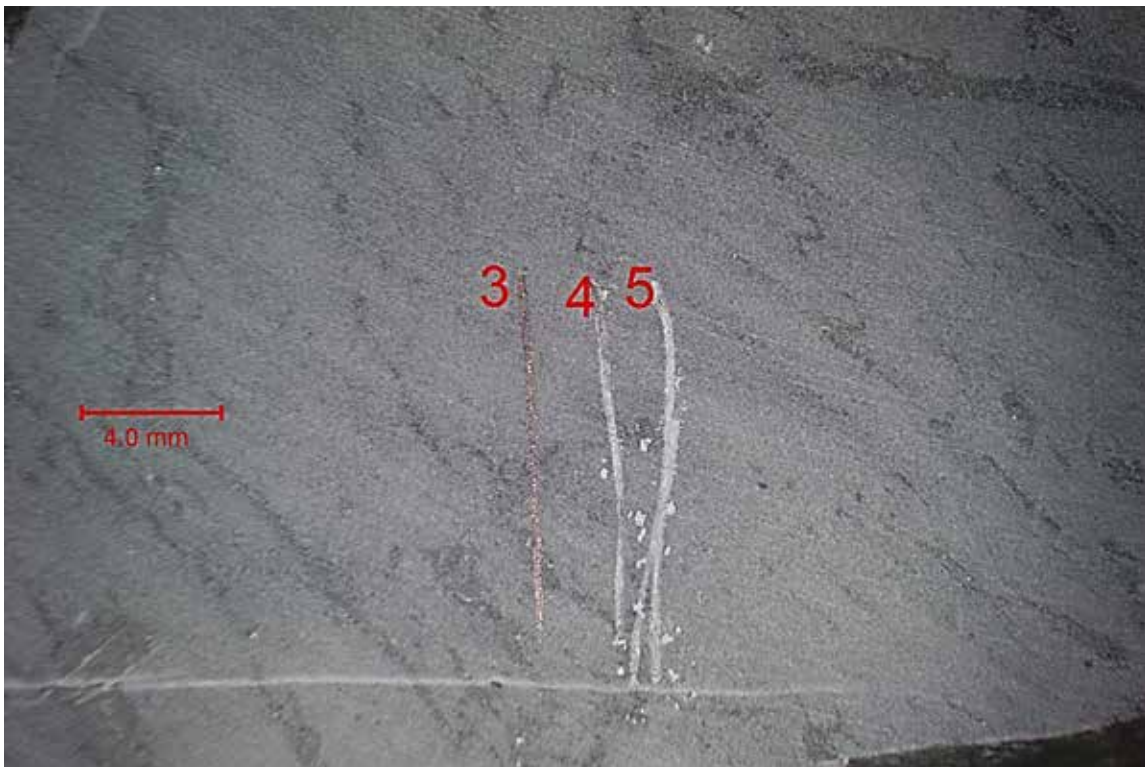
**PHOTO: 4**

**SAMPLE ID:** #6 Gun Metal Marble  
**MAG:** 5x

**DESCRIPTION:** View of the lapped cross section of the stone after Mohs hardness testing. Note that hardness pick 3 did not scratch and hardness picks 4 and 5 scratched all minerals. The general Mohs hardness would be approximately 3.5.

1. The overall hardness of the "#6 Gun Metal Marble" stone is approximately 3.5 on the Mohs scale. The number is based upon testing values of the overall hardness of the rock using Mohs hardness picks.

2. The stone appeared to generally consist of a fine grained, sedimentary rock. A hardness value determination of the stone based upon the mineral assemblage was not conducted. Mohs picks with hardness 3 thru 5 were used on the stone. The Mohs hardness picks determined an approximate overall hardness of 3.5. This hardness is a more consistent result than using the mineral assemblage because the Mohs hardness picks were drawn directly across a freshly lapped surface of the stone.
