Material Test Report

Report No: MAT:16-07878-S2
Issue No: 1

Client: KAFKA GRANITE, LLC
Project: 2016 CONSTRUCTION PROJECTS
Job No: 12-02155

Re: Mohs Hardness Testing
2016 Construction Projects
Schofield, WI
AET Project No. 12-02155

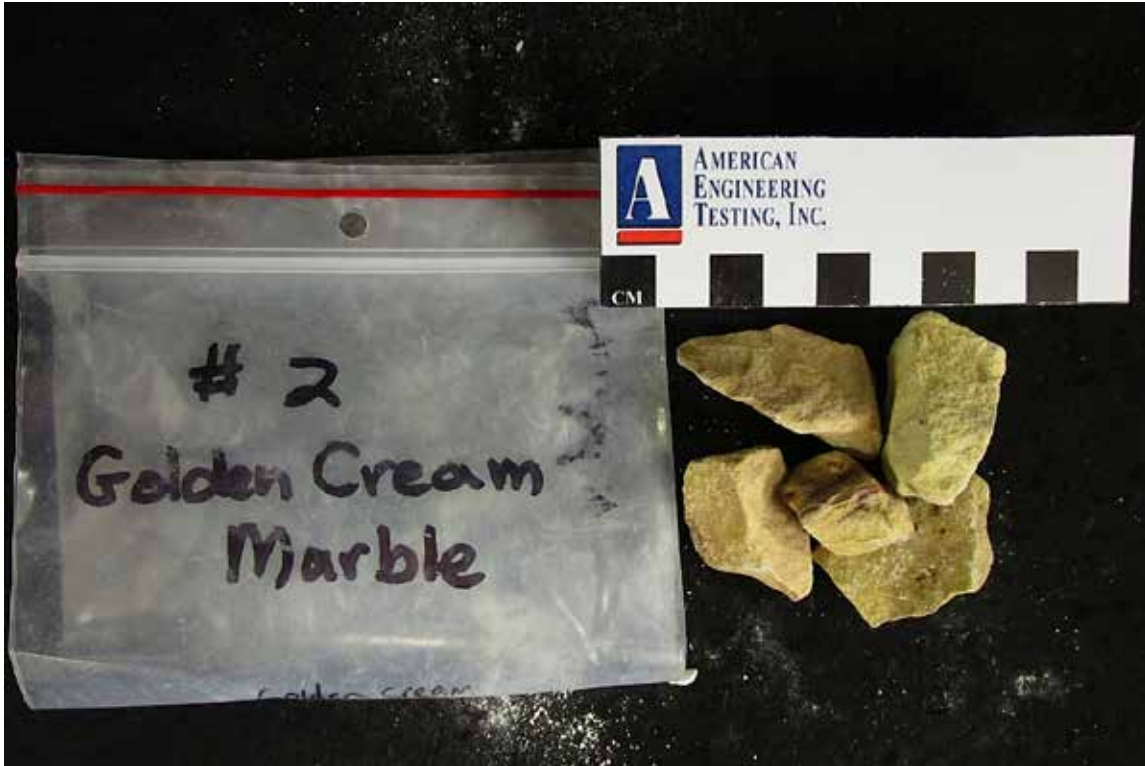
PHOTO: 1

SAMPLE ID: #2 Golden Cream Marble DESCRIPTION: Overall view of the sample as received.

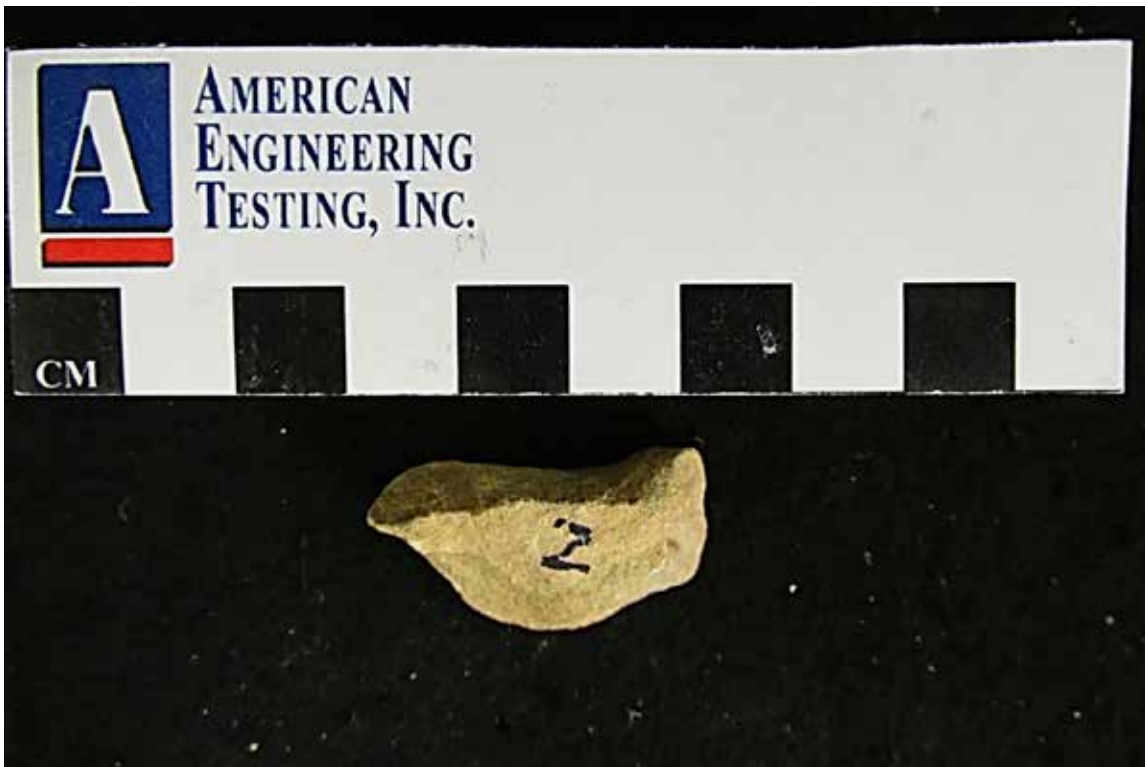
PHOTO: 2

SAMPLE ID: #2 Golden Cream Marble DESCRIPTION: View of the stone selected for hardness testing.

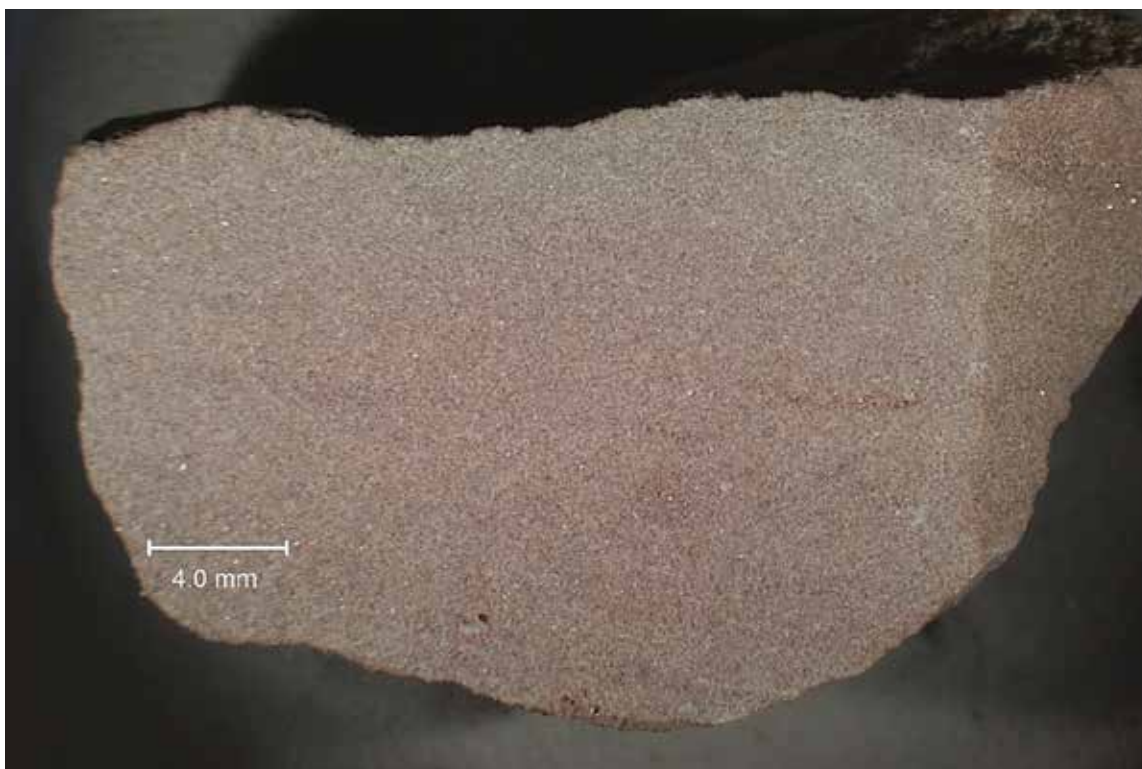
PHOTO: 3

SAMPLE ID: #2 Golden Cream Marble
MAG: 5x
DESCRIPTION: View of the lapped cross section of the stone.

Our work was performed on July 26, 2016 and subsequent dates. The hardness testing was completed through the use of standard geologic Mohs hardness points and optical microscopy on a lapped hand sample. The review was performed in general accordance with Standard Operating Procedure 24-LAB-004, "Petrographic Examination of Aggregates for Concrete, ASTM C295." Observations were made using an Olympus SZX-12 stereo-zoom binocular microscope with magnification up to 160x.

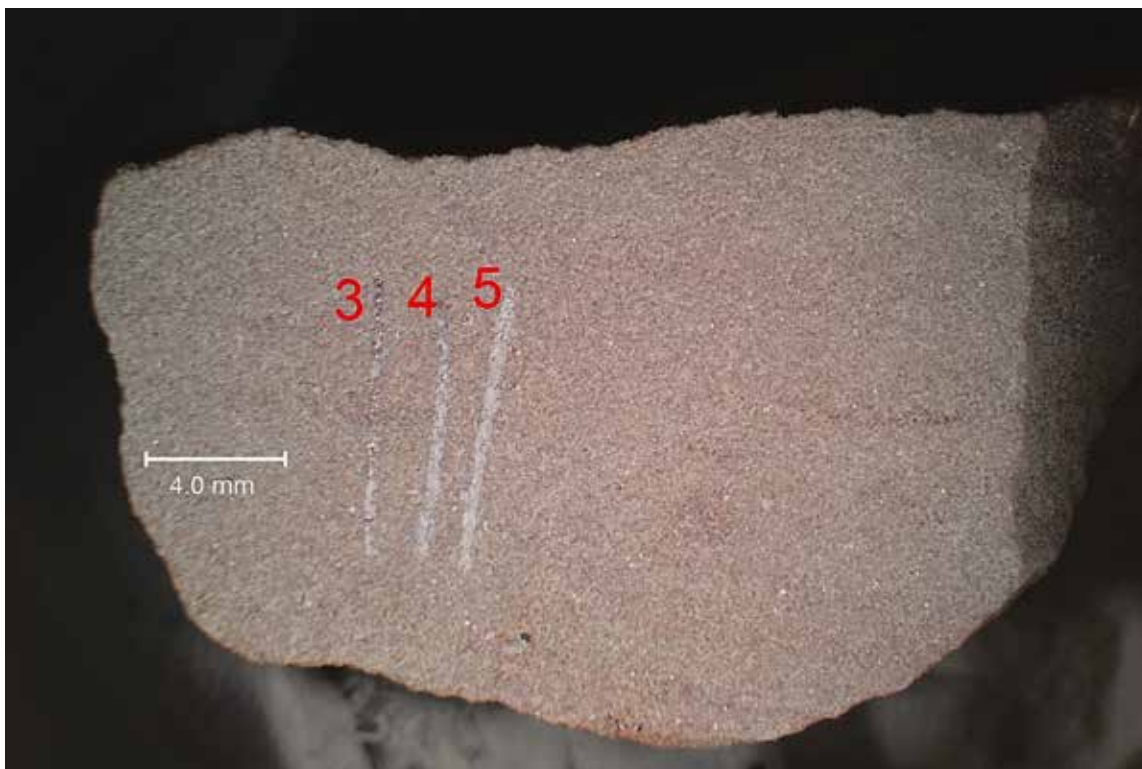
PHOTO: 4

SAMPLE ID: #2 Golden Cream Marble
MAG: 5x
DESCRIPTION: View of the lapped cross section of the stone after Mohs hardness testing. Note that hardness pick 3 scratched a few minerals, hardness pick 4 scratched almost all of the minerals, and hardness pick 5 scratched all minerals. The general Mohs hardness would be approximately 3 to 3.5.

1. The overall hardness of the "#2 Golden Cream Marble" stone is approximately 3 to 3.5 on the Mohs scale. The number is based upon testing values of the overall hardness of the rock using Mohs hardness picks.

2. The stone appeared to generally consist of a fine grained, sedimentary rock. A hardness value determination of the stone based upon the mineral assemblage was not conducted. Mohs picks with hardness 3 thru 5 were used on the stone. The Mohs hardness picks determined an approximate overall hardness of 3 to 3.5. This hardness is a more consistent result than using the mineral assemblage because the Mohs hardness picks were drawn directly across a freshly lapped surface of the stone.
