Material Test Report

Report No: MAT:16-07878-S10
Issue No: 1

Client: KAFKA GRANITE, LLC
Project: 2016 CONSTRUCTION PROJECTS
Job No: 12-02155
CC: Jeremy Bores
 John Meyer

Re: Mohs Hardness Testing
2016 Construction Projects
Schofield, WI
AET Project No. 12-02155

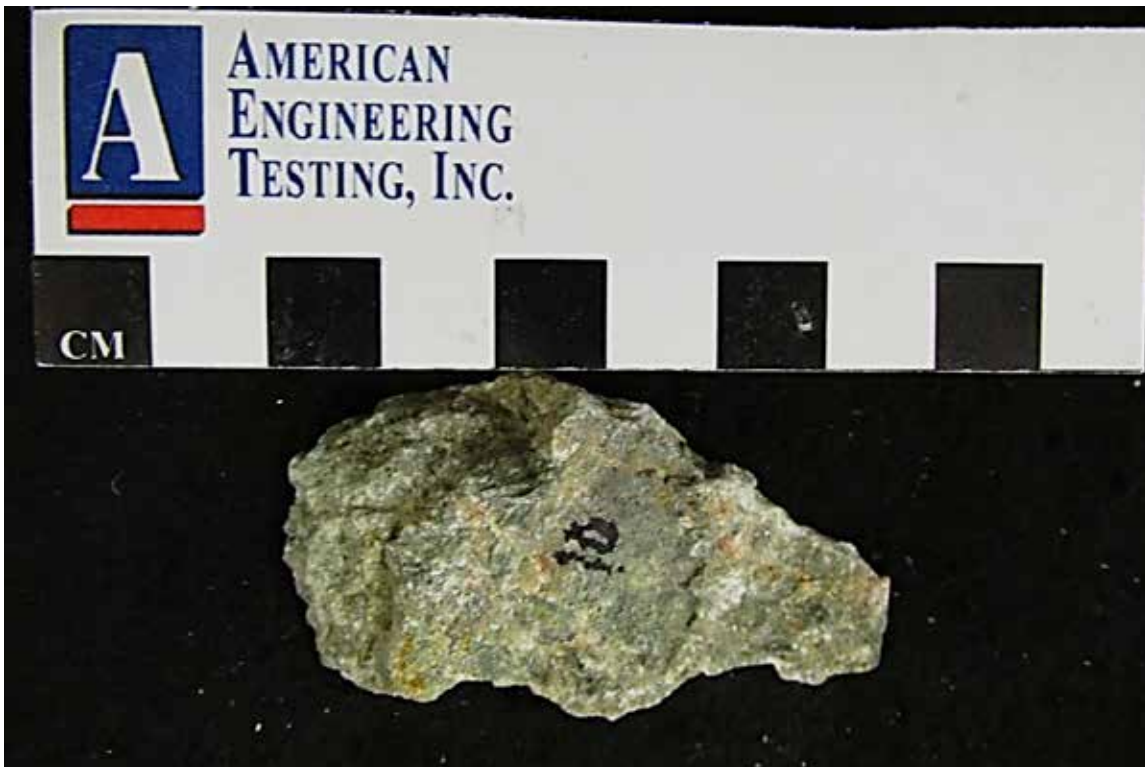
PHOTO: 2

SAMPLE ID: #10 Misty Grey Marble DESCRIPTION: View of the stone selected for hardness testing.

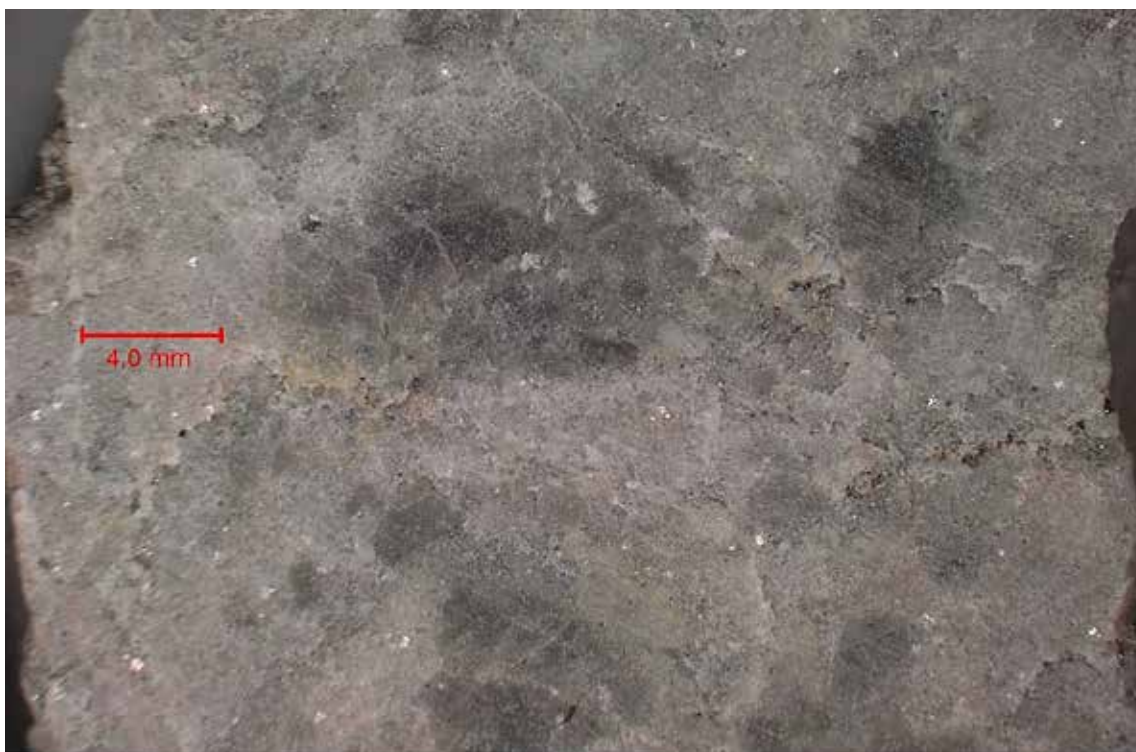
PHOTO: 3

SAMPLE ID: #10 Misty Grey Marble
MAG: 5x
DESCRIPTION: View of the lapped cross section of the stone.

Our work was performed on July 26, 2016 and subsequent dates. The hardness testing was completed through the use of standard geologic Mohs hardness points and optical microscopy on a lapped hand sample. The review was performed in general accordance with Standard Operating Procedure 24-LAB-004, "Petrographic Examination of Aggregates for Concrete, ASTM C295." Observations were made using an Olympus SZX-12 stereo-zoom binocular microscope with magnification up to 160x.
